6. Damage to Buildings by Earthquake Motions

6.1 Policy on Earthquake Damage Investigation for Buildings

6.2 Damage to Wood Houses

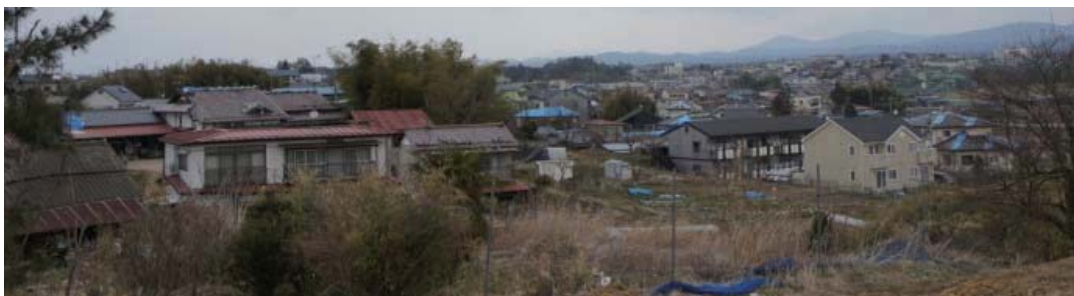
Another collapsed building with uncertain structural type was found (Photo 6.2-53). According to the damage overview seen from the east of Minami-machi (Photo 6.2-54), it was observed that the wood houses with roof covered temporarily with blue vinyl sheet which was guessed to be damaged to roof tiles were relatively many.

Photo 6.2-54 Damage overview from the east of Minami-machi (Many roofs covered with blue vinyl sheet)

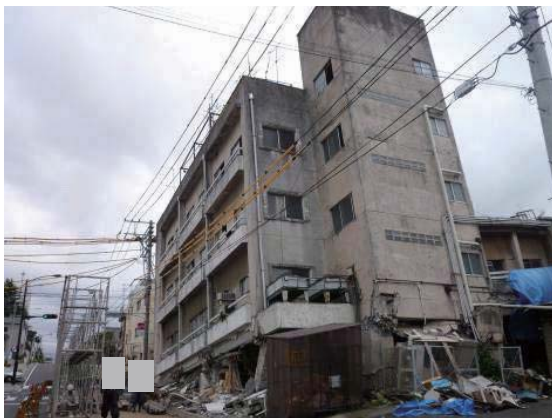
The soft-first story collapse occurred on a four-story RC residential building with a shop in the first floor in Koriyama city, and was attributed to the shear failure of the columns on the first story and the torsional deformation (Photos 6.3-2 and 6.3-3). The RC shear wall on the first story was collapsed out-of-plane with buckling of reinforcing bars.

Photo 6.3-2 First-story collapsed building (Koriyama city)

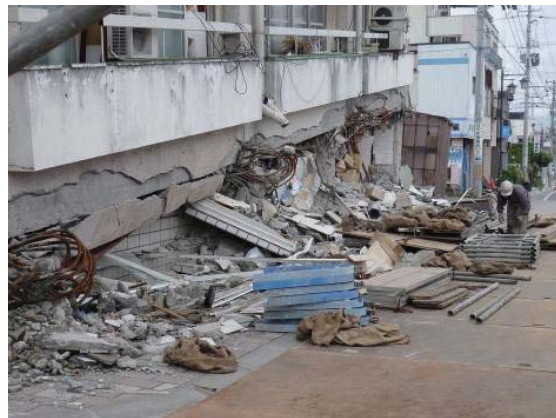
Photo 6.3-3 Close-up view of the fallen story

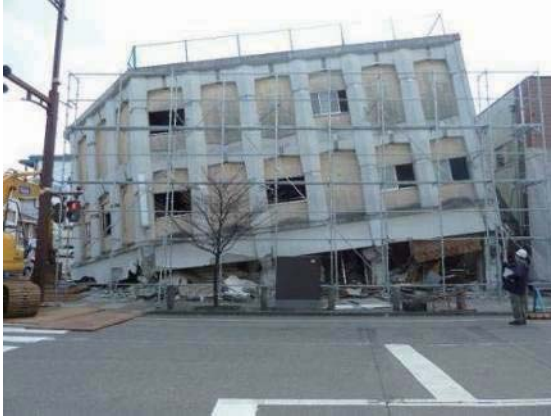
A three-story RC building shown in Photo 6.3-4 was severely damaged on the first story, which was located at the intersection in Sukagawa city, had a few walls on the facade on the first story and many walls on the back of the first story and the second story and higher. The corner columns faced to the intersection were significantly destroyed as shown in Photo 6.3-5. The loss of axial load carrying capacity of the first-story columns caused the drop of the second and higher stories.

Photo 6.3-4 First-story collapsed building (Sukagawa city)

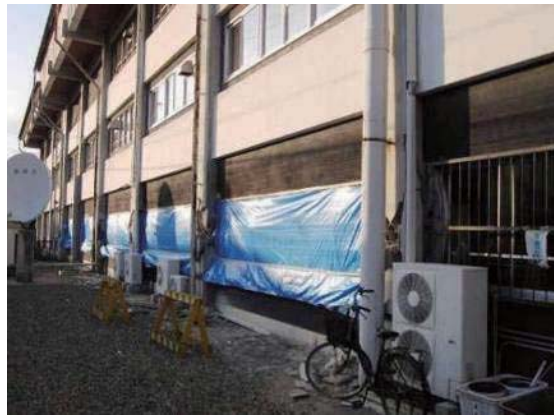
A three-story RC building constructed in 1963 was suffered from the shear failures of columns in Tono city of Iwate prefecture, where the JMA seismic intensity was 5 upper (5+) (Photo 6.3-9). Two extremely short columns on the first-story, four columns on the northern plane of structure and an interior shear wall were failed in shear as shown in Photo 6.3-10, and short columns with spandrel wall, some long columns on the southern plane of structure had shear cracks. The post-earthquake damage evaluation ^{6.3-2)} was conducted for the building in the longitudinal direction. In the result, the building was determined to represent heavy damage (residual seismic performance ratio, $R=57.8\%$). The building had been damaged in the South Sanriku Earthquake in 2003 (JMA seismic intensity 6 lower). For this reason, cover concrete was then recast on the shear-cracked columns, and the existing columns were temporary strengthened with H-shaped steel, as shown in Photo 6.3-11. However, the 2011 Tohoku earthquake affected these columns again.

Photo 6.3-9 Appearance of the damaged building (Tono city)

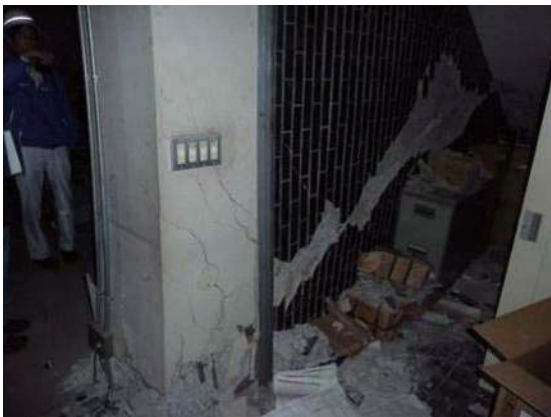
Photo 6.3-10 Shear crack on shear wall

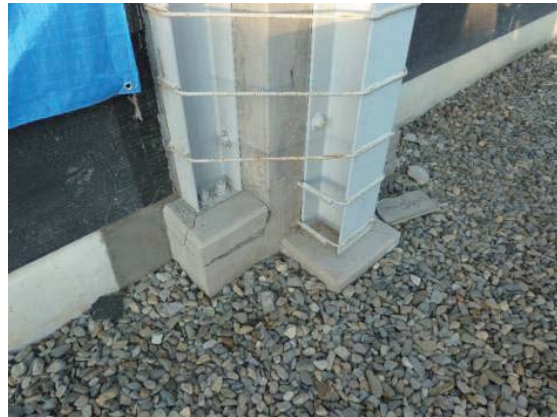
Photo 6.3-11 Column strengthened with H-shaped steel

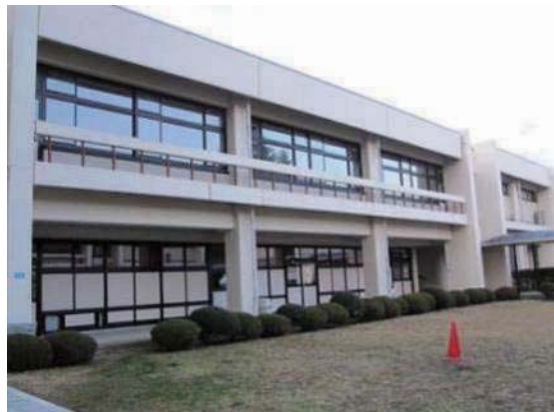
The next case is that the shear failure occurred on the first-story columns in a two-story RC building in Aoba ward, Sendai city (Photos 6.3-12 and 6.3-13). Some columns of the building were intact after the mainshock on March 11, but aftershocks caused shear failure to some of them, as shown on the right of Photo 6.3-13. It was confirmed that the aftershocks accelerated the damage level of this building.

Photo 6.3-12 Appearance of the damaged building (Aoba ward, Sendai city)

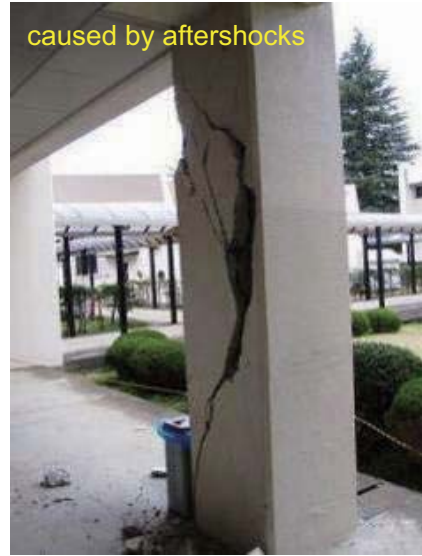
Photo 6.3-13 Shear cracks of first-story columns

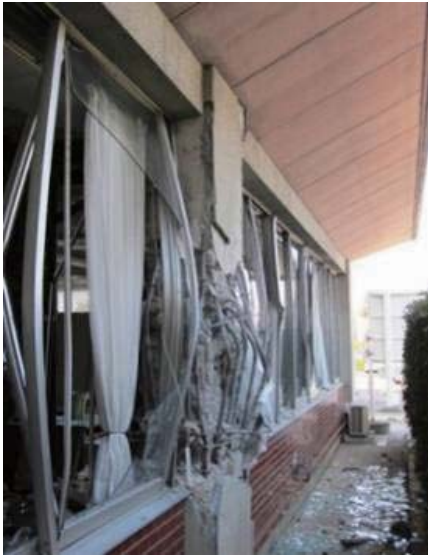
Photo 6.3-15 Shear failure of short column

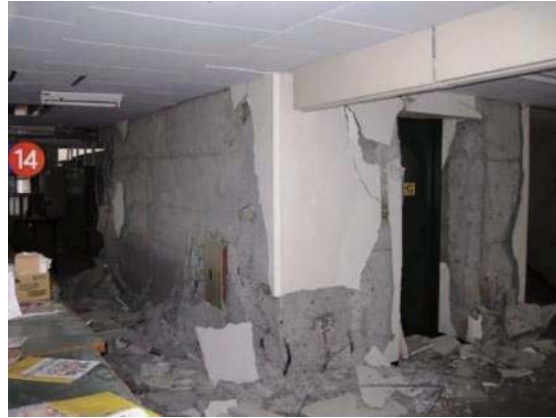
Photo 6.3-16 Failure of shear wall

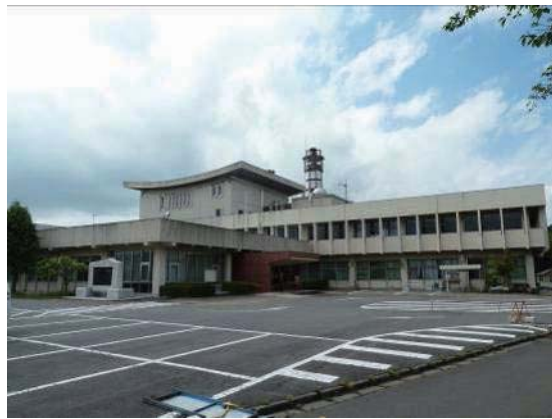
A three-story RC building constructed in 1964 on a hill in Kasama city of Ibaraki prefecture shown in Photo 6.3-17 also suffered damage. Cracks in the ground were observed around the building. As seen in the photo, the RC structure on the first story was severely damaged. Shear failure occurred on many exterior columns, which were made shorter in clear height by the hanging and spandrel walls without structural slit, as shown in Photo 6.3-18. In addition, the failure of the shear wall with opening was observed (Photo 6.3-19).

Photo 6.3-17 Appearance of damaged building (Kasama city)

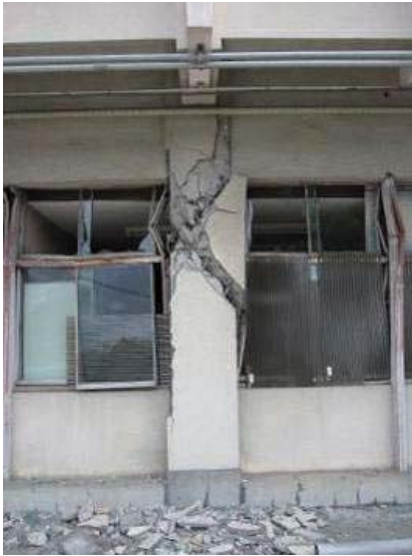
Photo 6.3-18 Shear failure of column

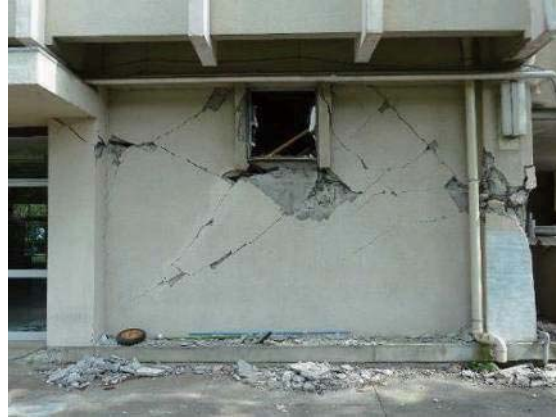
Photo 6.3-19 Shear failure of wall with opening

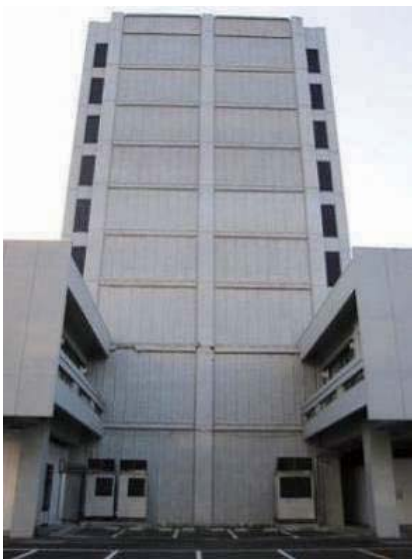
A building that consists of nine-story SRC and two-story RC structures in Aoba ward, Sendai city suffered from the earthquake (Photo 6.3-20). In the high-rise building, the multi-story shear wall of the gable side was subject to flexural failure at the third floor. Crushing of concrete and buckling of the longitudinal reinforcements was observed at the bottom of the boundary column of shear wall, as shown in Photo 6.3-21. This building was also damaged by the Miyagiken-oki Earthquake in 1978 and had been retrofitted.

Photo 6.3-20 Appearance of damaged building (Aoba ward, Sendai city)

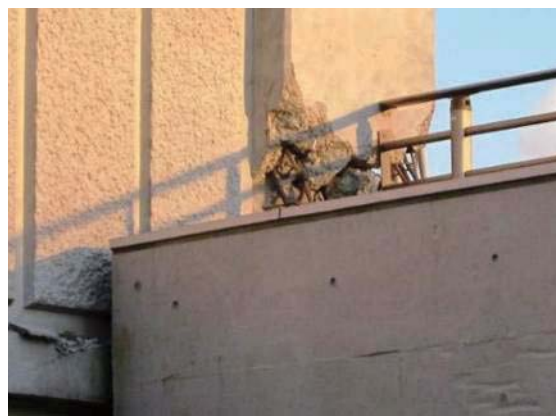
Photo 6.3-21 Crushing at the bottom of column of the multi-story shear wall

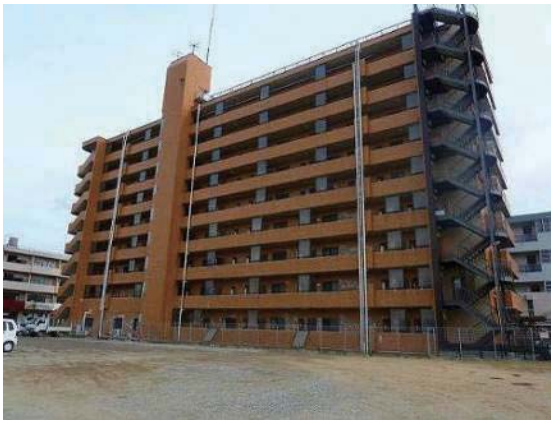
Photo 6.3-22 shows the appearance of a damaged building, which is the nine-story SRC residential building constructed in 1991 in Koriyama city of Fukushima prefecture. Pullout of anchor bolts, buckling of reinforcing bars and compressive failure of concrete occurred at the corner column and the bottom of multi-story shear wall in the first story, as shown in Photo 6.3-23, and shear cracks and bond splitting cracks were observed on the first story columns.

Photo 6.3-22 Appearance of damaged building (Koriyama city)

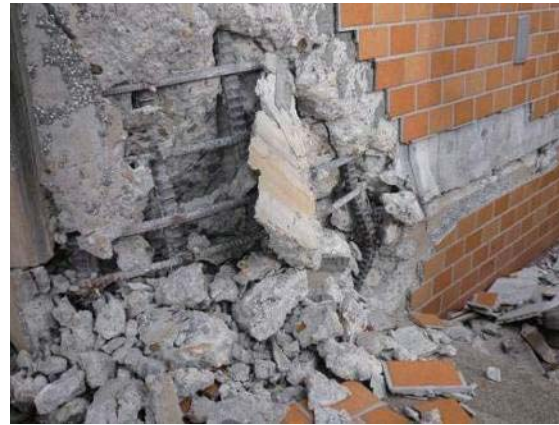
Photo 6.3-23 Damage at the bottom of SRC column

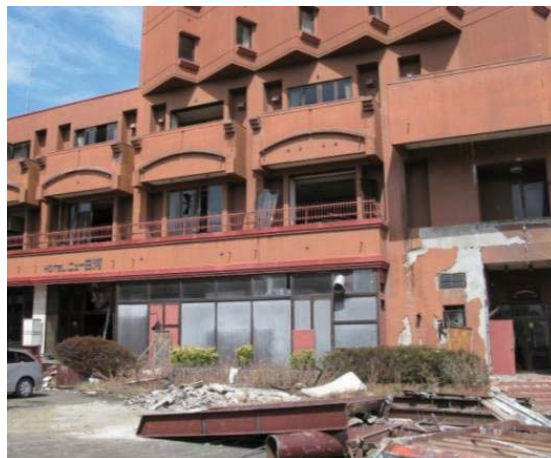
The damage at the bottom of SRC column and shear wall was also observed on a building in Shirakawa city shown in Photos 6.3-24 and 6.3-25, which was composed of RC and SRC structures. Pullout of anchor bolts of the exposed-type column base occurred. In consequence, the reinforcing bars were forced to stretch large and the buckling of them occurred around the base plate, as shown in Photo 6.3-26.

Photo 6.3-24 Appearance of damaged building (Shirakawa city, Fukushima pref.)

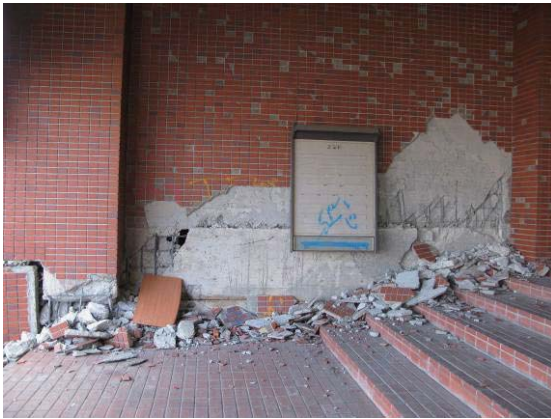
Photo 6.3-25 Damage of the bottom of SRC column and shear wall

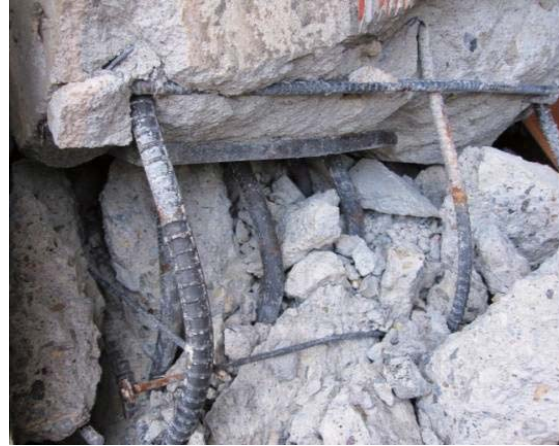
Photo 6.3-26 Close-up view of the bottom of SRC column

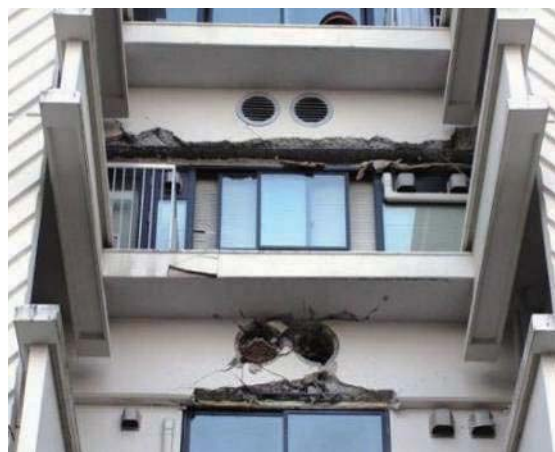
Photo 6.3-28 Damage of boundary beam with opening

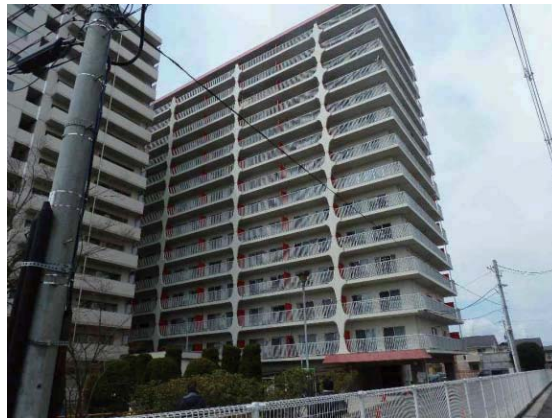
A fourteen-story RC building shown in Photo 6.3-29 was settled down and was tilted about 1/70 radian. The building is one of two residential buildings located in L-shape with expansion joint in Miyagino ward, Sendai city. The shear cracks on the nonstructural walls over every story and some parts of mullions occurred in both buildings as shown in Photos 6.3-30 and 6.3-31, which damage was classified as B-2). Though the other building without inclination had same shear cracks on the nonstructural walls from first to sixth story in the Miyagiken-oki Earthquake in 1978 and had been repaired with concrete replacement, almost same damage was happened on the similar part.

Photo 6.3-29 Appearance of tilted building (Miyagino ward, Sendai city)

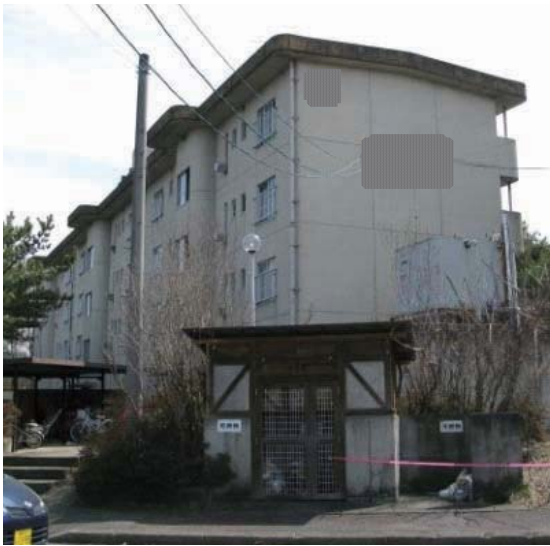
Photo 6.3-32 Appearance of sunken and leaned building (Shirakawa city)

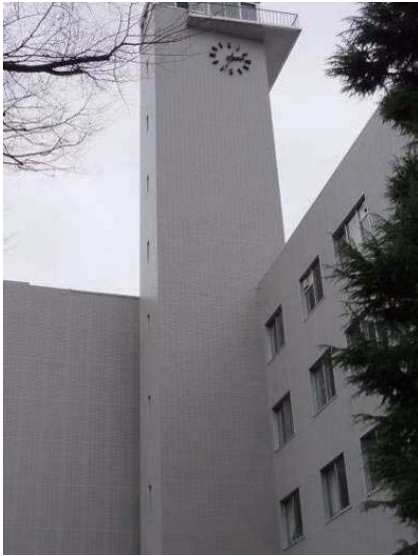
Photo 6.3-35 Damaged clock tower
(Fukushima city)

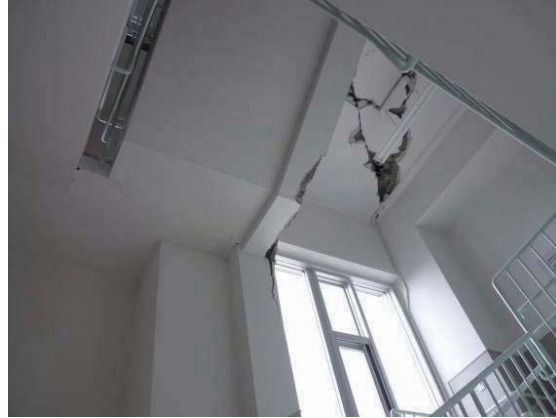
Photo 6.3-36 Bottom of the tower

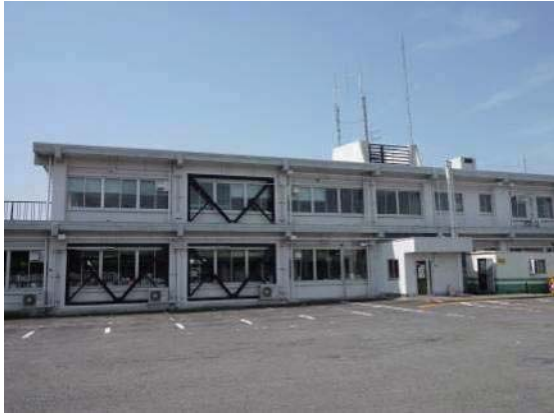
Photo 6.3-37 Appearance of damaged building (Hitachiomiya city)

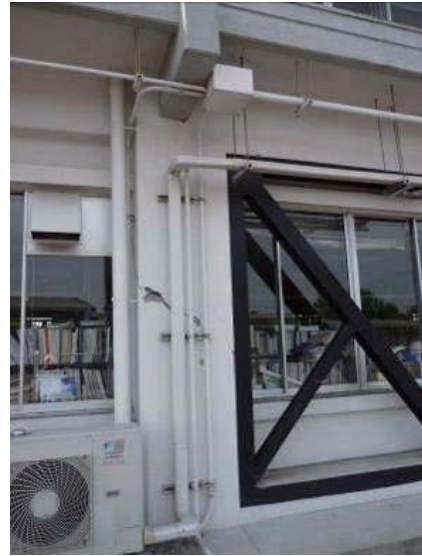
Shear cracks occurred on the columns with the framed steel braces at the 2011 Tohoku earthquake as shown in Photo 6.3-38, although the remarkable damage such as yield of steel was not seen on the braces. Flexural cracks at the beam ends of the second-story in the span direction and shear cracks at the beam ends of the third-story were observed, respectively. A maximum deflection of 128mm was happened at the center in the span direction with a span of 12m. It would appear that the deflection was increased due to the damage occurred on the beam end by the earthquake, though the under-surface of the beam has been strengthened. Because the beam had cracks caused by the past earthquake, it had been reinforced with steel plates in the range of quarter beam length from the column.

Photo 6.3-38 Shear crack on column with framed steel braces

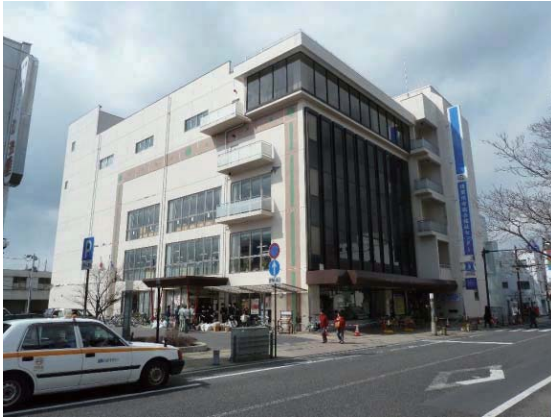
The separation of cover concrete at the bottom of wing wall was observed on a five-story RC building constructed in 2007 in Sukagawa city of Fukushima prefecture, as shown in Photos 6.3-39 and 6.3-40. In this report, that case is classified as the damage of nonstructural elements, because the wing wall is generally designed as the nonstructural element, which is not expected to resist the external force.

Photo 6.3-39 Appearance of damaged building (Sukagawa city)

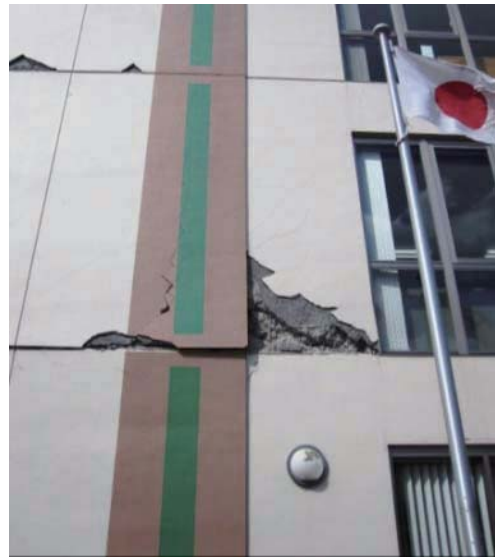
Photo 6.3-40 Separation of concrete of wing wall

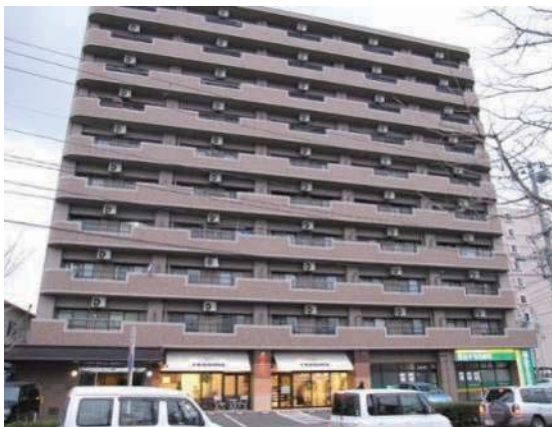
The nonstructural walls around the front doors from lower to top floors were subject to shear failure, while the doors were deformed on a ten-story SRC residential building constructed in Aoba ward, Sendai city in 1996, as shown in Photos 6.3-41 and 6.3-42. In addition, shear cracks were observed on the mullion walls on balconies in some of the lower floors.

Photo 6.3-41 Appearance of damaged building (Aoba ward, Sendai city)

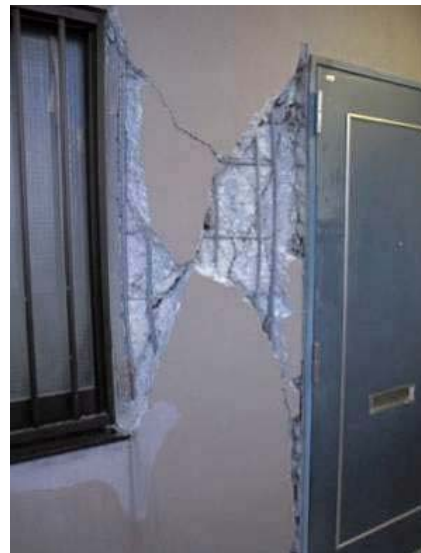
Photo 6.3-42 Shear failure of nonstructural wall

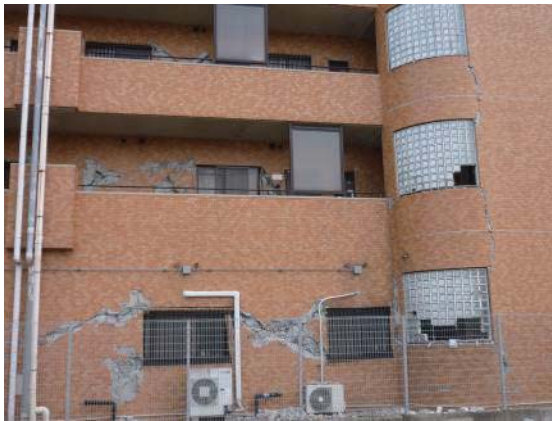
The cases where shear cracks occurred on the nonstructural walls around the front door or on the mullion wall of the balcony were relatively often observed in urban residential buildings, regardless of application of the seismic design codes.

Photo 6.3-43 Damage of nonstructural wall in same building shown in Photo 6.3-22 (Koriyama city, Fukushima pref.)

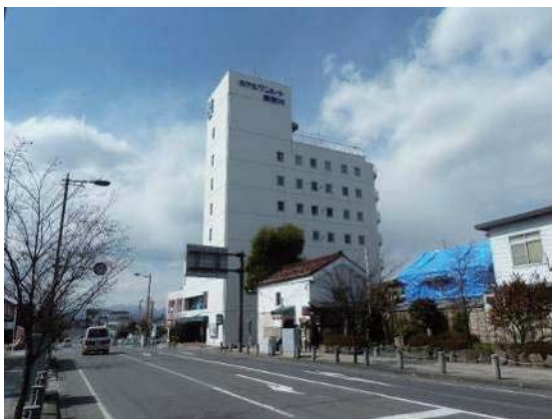
Photo 6.3-45 Appearance of damaged building (Sukagawa city)

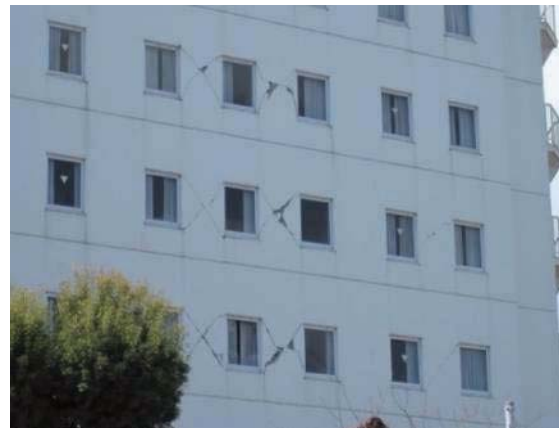
Photo 6.3-46 Shear crack on nonstructural wall

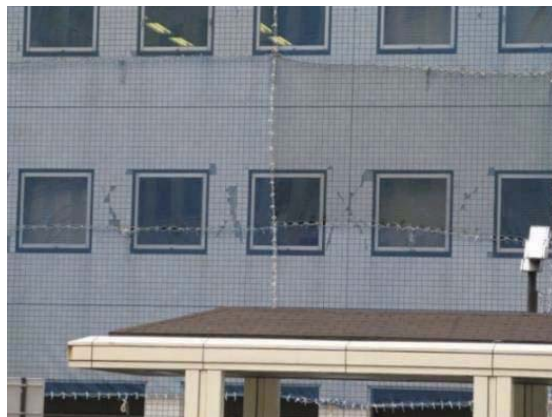
Photo 6.3-49 Damage of tile on exterior wall

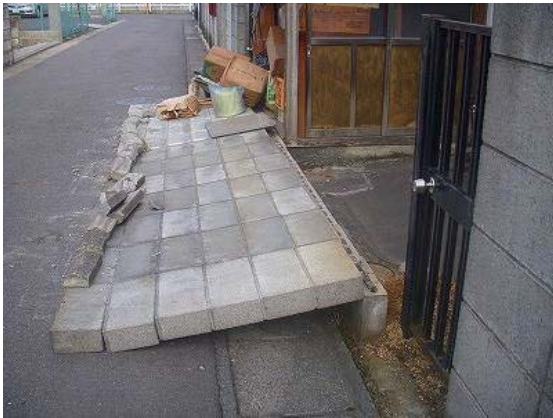
The collapse of concrete block wall and stone masonry wall are well known as earthquake damage caused by strong seismic motion. The damage of that type was often observed in the field investigation, as shown from Photo 6.3-50 to Photo 6.3-53.

Photo 6.3-50 Collapse of concrete block wall (Koriyama city)

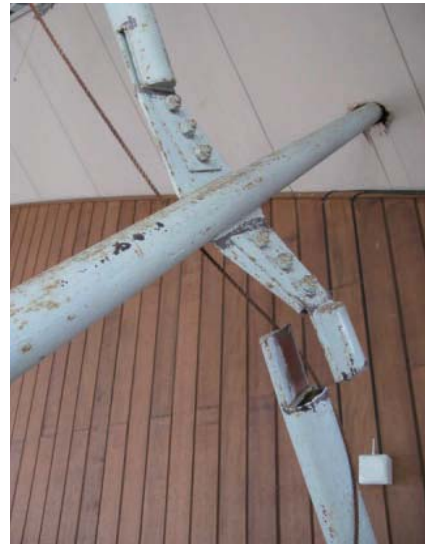
(b) Fracture at brace crossing

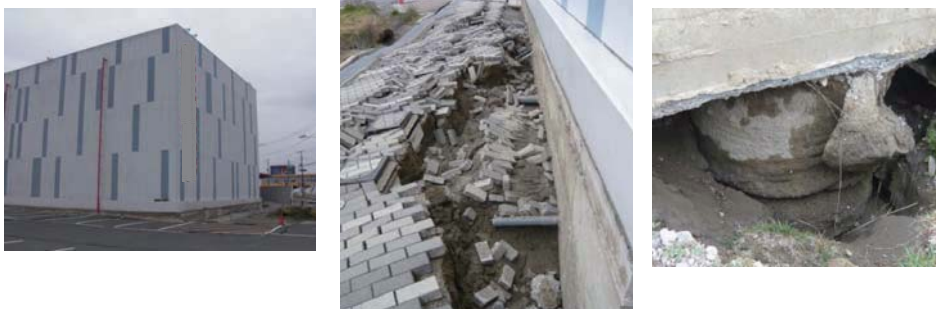
Finishes of the sidewalks around a large-scale commercial establishment along Route 11 were scattered. The subsidence of the surrounding ground was about 40 cm, and the settlement of the facility itself was slight. The commercial building was tilted about 0.7/100 in the longitudinal direction. The pile foundation of the building was observed from an opening between surrounding fissures (Photo 6.5-1).

Photo 6.5-1 Situations around the commercial building and state of pile head

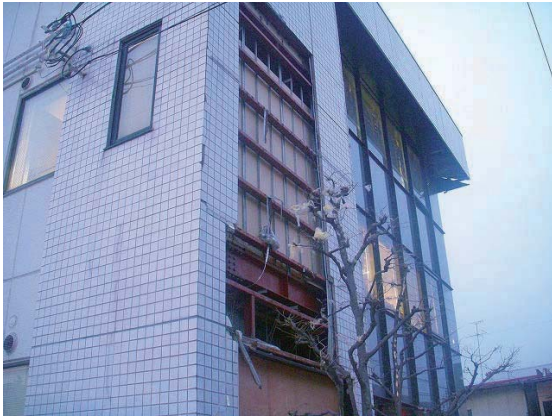
Damage to cement mortar and metal lath exterior walls was often observed in steel buildings. Photo 6.6-3 shows detachment of cement mortar and metal lath exterior wall in a 3-story building. Damage to the window glass was not observed, but cement mortar and metal lath fell from the exterior wall (shown in Photo 6.6-3) and from the parapet on another side. Photo 6.6-4 shows a one-story steel building in which cement mortar and metal lath detached from an exterior wall and from an eaves soffit. Photo 6.6-5 shows a damaged gable end wall of a gymnasium. This wall consisted of two layers. The undersurface wall was cement mortar and metal lath exterior wall. The surface one was exterior boards nailed to furring installed on the undersurface wall. Both were damaged and fell by the earthquake.

Photo 6.6-3 Falling of cement mortar and metal lath wall

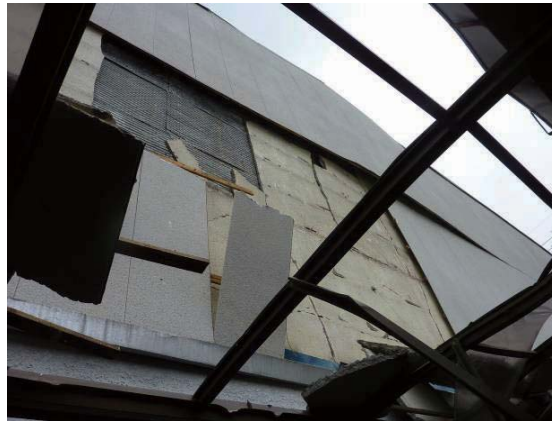
Photo 6.6-5 Damage to gymnasium gable end wall

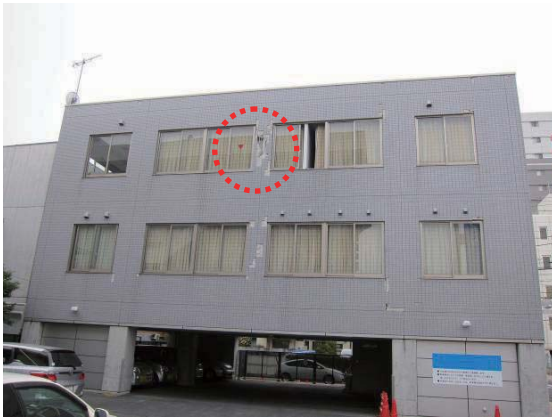
Photo 6.6-6 Falling of ceramic wall tiles and breakage of AAC panels

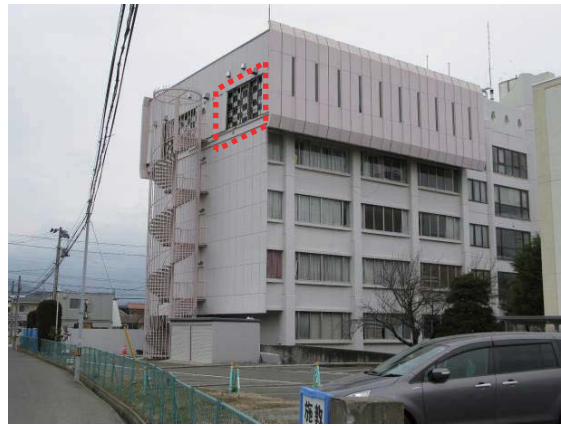
observed in the external survey. Photo 6.6-7 shows falling of AAC panels from the top-floor of a 5-story building. The damaged AAC panels were observed to be installed to the support metal with cement mortar and steel bar. This AAC construction method appeared in 3rd edition of Japanese Architectural Specification Standard JASS 12 as one of standard construction methods for AAC panel exterior wall but not included in its 4th edition. ^{6.6-3)} ^{6.6-4)} AAC panels installed with this AAC construction method were frequently observed to be damaged.

Photo 6.6-7 Detachment of AAC panels

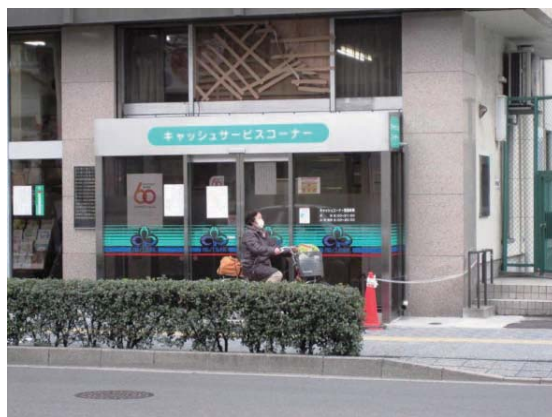
Photo 6.6-8 shows broken window glasses in the upper area of a windbreak room on the ground level of a 5-story building. Exterior ceramic wall tiles fell from another side.

Photo 6.6-8 Broken window glass

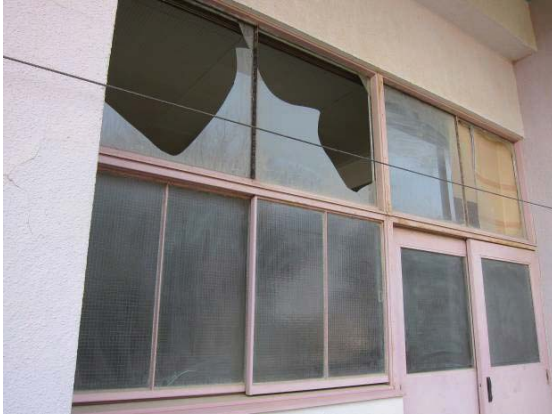
Photo 6.6-9 Breakage of window glasses installed to fixed window frame with hardening putty

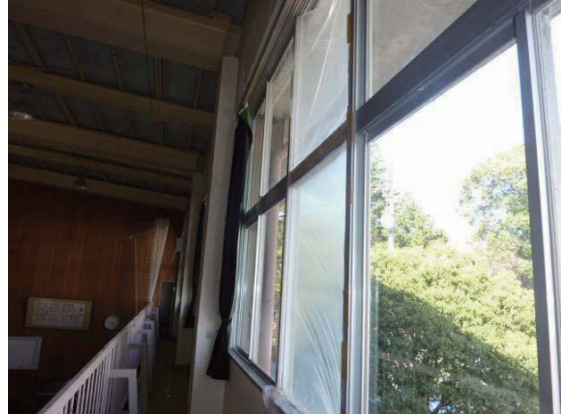
Photo 6.6-10 Breakage of window glasses installed to fixed window frame with glazing bead

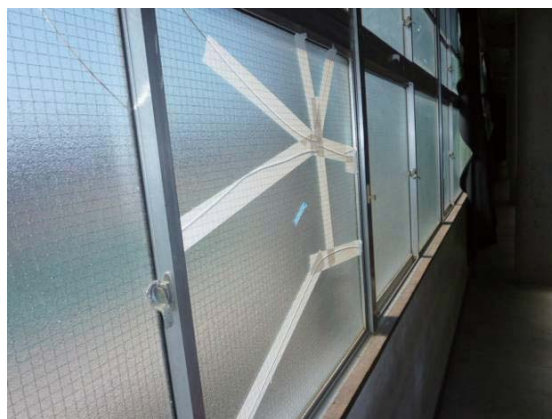
Photo 6.6-11 shows broken window glasses on the longitudinal surface in a gymnasium. Twenty-six wired window glasses were broken, which were installed to double sliding window frames with glazing bead. On the windows of opposite side, there were no damage to the frosted window glasses and a detachment of a mullion cover of a window. No damage was observed in the structure.

Photo 6.6-11 Breakage of wired window glass installed to double sliding window frame with glazing bead

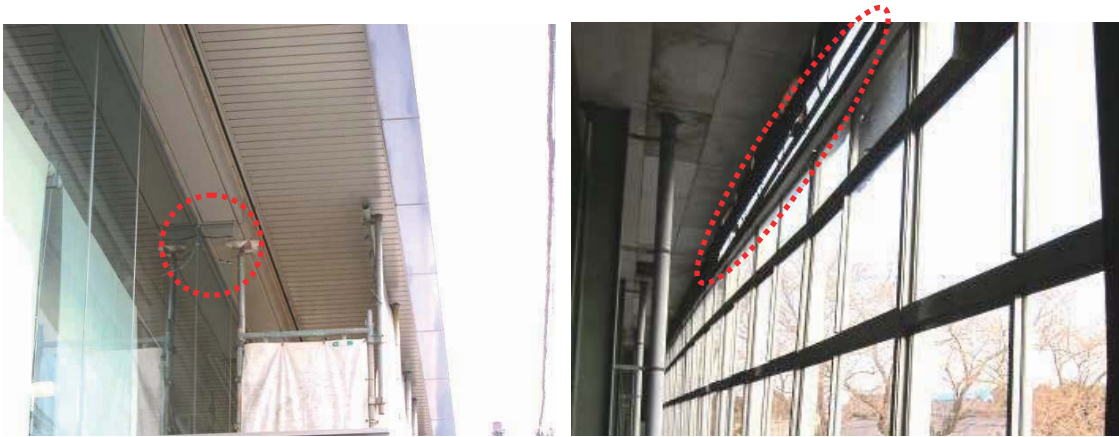
Photo 6.6-12 Breakage of glass mullion of glass wall system Photo 6.6-13 Dislocation of window frame

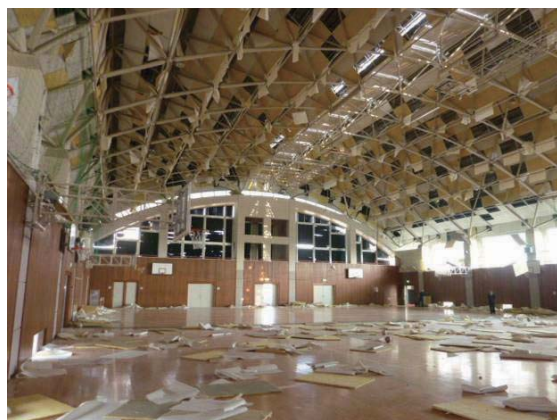
In the gymnasium shown in Photo 6.6-18, many glass wool boards on exposed T system fell. Flaking of concrete was observed in the structure.

Photo 6.6-18 Falling of glass wool board of T system ceiling

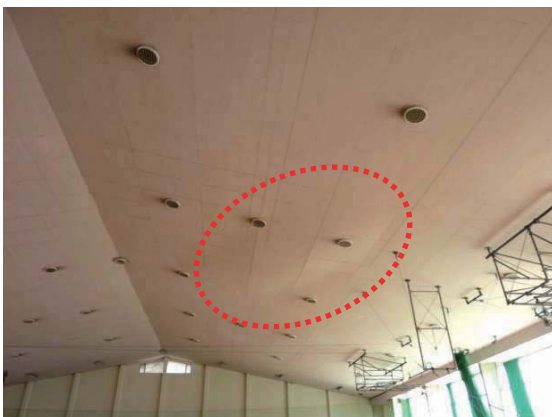
Photo 6.6-19 Sagging of metal furring suspended ceiling

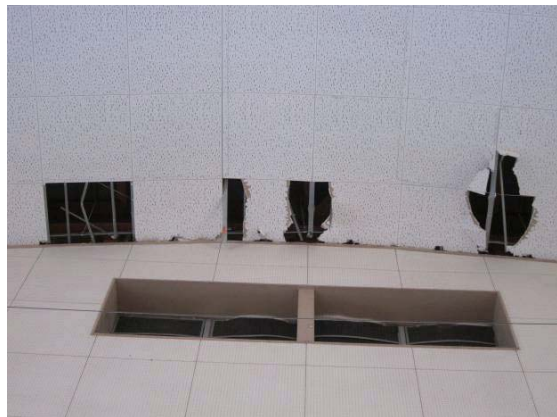
Photo 6.6-20 Damage to metal furring ceiling at the connection wall

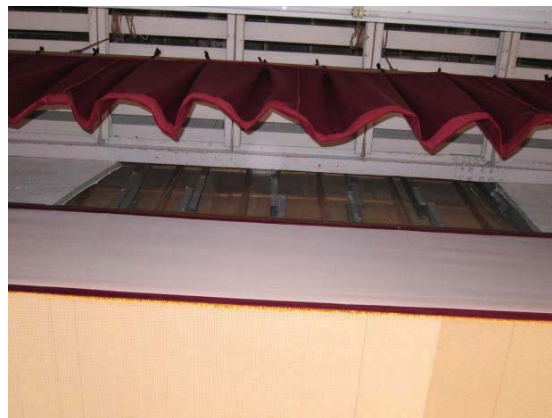
Photo 6.6-23 Falling of cement mortar finish above stage

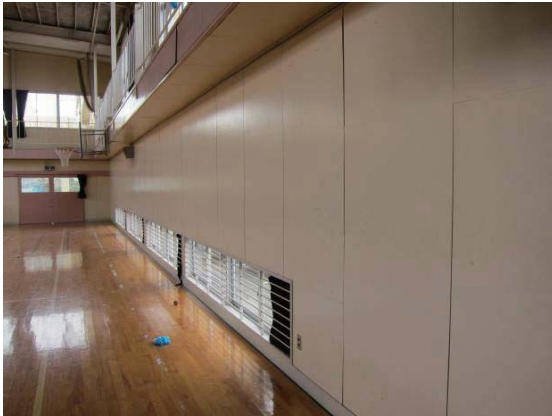
Photo 6.6-24 Loosen nails fixing board

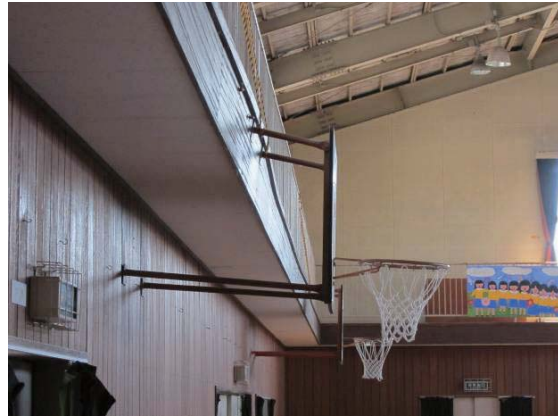
Photo 6.6-25 Damaged interior wall
