6.5 Damage to Residential Land

6.5.1 Introduction

The outline of damage situations associated with liquefaction in the alluvial plain area along the Tone River on the border between Ibaraki and Chiba prefectures and in Urayasu city, Chiba prefecture is reported. Furthermore the outline of damage situations of developed housing areas in Miyagi and Fukushima prefectures is also reported.

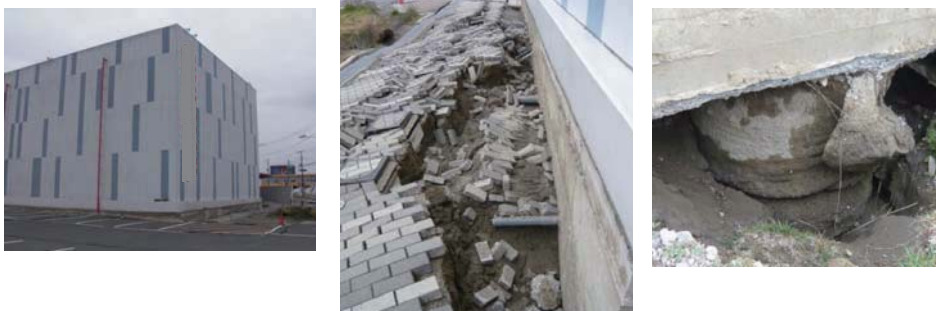
Finishes of the sidewalks around a large-scale commercial establishment along Route 11 were scattered. The subsidence of the surrounding ground was about 40 cm, and the settlement of the facility itself was slight. The commercial building was tilted about 0.7/100 in the longitudinal direction. The pile foundation of the building was observed from an opening between surrounding fissures (Photo 6.5-1).

Photo 6.5-1 Situations around the commercial building and state of pile head

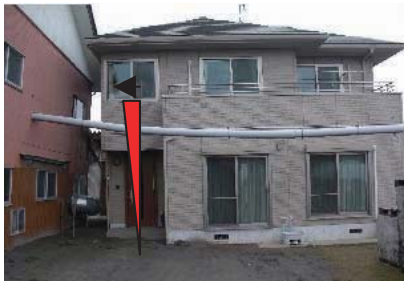
A boiled sand was seen everywhere on the roads or sites also in surrounding residential area. A house constructed on an embankment was tilted to an adjacent warehouse with sand boiling. An angle of tilting was 5.0/100 (Photo 6.5-2).

Photo 6.5-2 House tilted 5.0/100

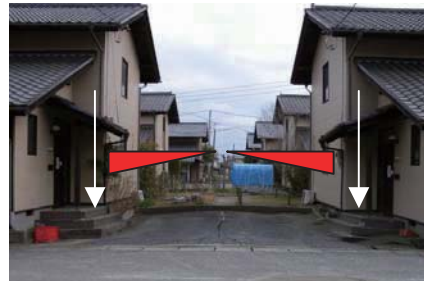
In Hinode, large-scale damage occurred in the area of about 200 m by 200 m along the Hitachi-tone River. Boiled sand, uplift of buried structures, and subsidence or tilting of utility poles, which were caused by liquefaction, were seen everywhere on the site. Many houses facing to the road subsided 20 to 30 cm from the front sidewalk (Photo 6.5-3). Foundation cracks or gaps were not observed.

Photo 6.5-3 Subsidence of two houses enclosing vacant land

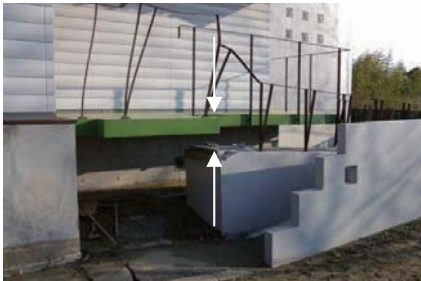
Yokose Elementary School is located about 3 km southeast from the Kamisu city office. The boiled sand by liquefaction was seen on the ground near the school. The ground subsidence was caused about 15 cm of difference in level on the rim of the building, and about 40 cm of difference in level at the outer slope (Photo 6.5-4). The building is supported by pile foundation. The outer slope and stairs were spread foundations, and the differential settlement was caused in this building.

Photo 6.5-4 Slope difference in level

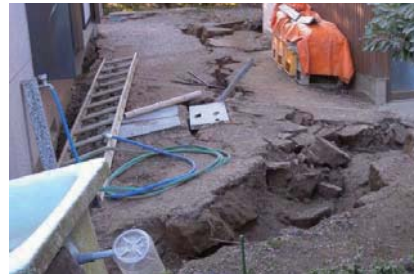
The types of damage, such as sand boiling, uplift of buried structures, road gaps and subsidence or tilting of utility poles which were caused by liquefaction, occurred in the area of about 300 m by 300 m near Sotonasakaura in the area of Tsutsui that is located in the western part of Kamisu city. Due to damage to residential land, a severe fissure was generated, a house subsided approximately 15 cm from the surrounding

ground and caused about 30 cm of difference in level from the ground (Photo 6.5-5). Cracking or crack fissures on the foundations were not visually observed.

Photo 6.5-5 Crack in the site

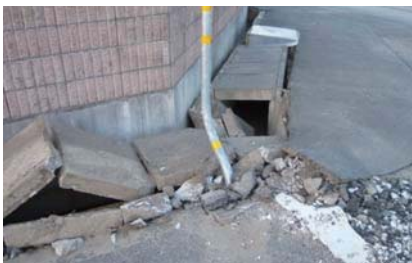
The uplift and the gap caused by site ground subsidence were occurred in the area of about 500 m by 500 m along Route 124 of national highway in Horiwari area that is located in the western part of Kamisu city. Along a street in the center of the area, uplift of the sidewalk or subsidence of the housing site caused a 25 to 30 cm of difference in level, and a side ditch around the house was damaged (Photo 6.5-6). A case where the ground around a house subsided about 15 cm without settlement of the house was observed. It is considered that the lower part of the sidewalk was damaged by the uplift of culverts.

Photo 6.5-6 Damage to side ditch

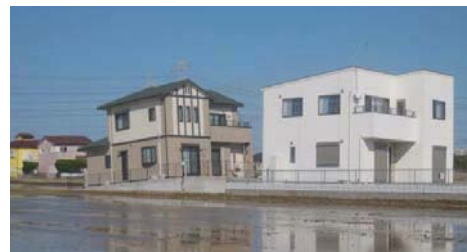
Fukashiba is located in the western part of Kamisu city and on the opposite side of Horiwai along Route 124. In this area, many houses were damaged due to ground deformation and embankment deformation. Most of the damage patterns of the houses seem to have included their movement, subsidence and tilting without structural damage on their upper structures and foundations (Photo 6.5-7).

Photo 6.5-7 Damage situations by liquefaction

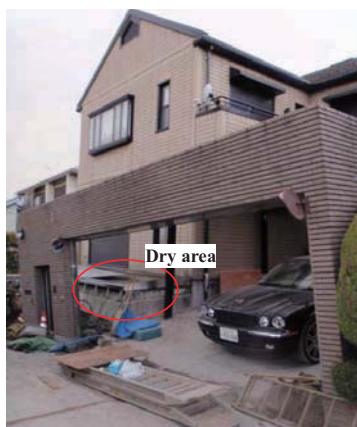
In Mihama, subsidence and tilting were observed in houses that have a dry area in the basement (Photo 6.5-8). An angle of tilting of the house was about 3 degrees. It is considered that the basement was uplifted and another remaining parts of the house was subsided. Around the house, in-site of house was totally covered with boiled sand by liquefaction, and a foundation of fence at site boundary was deformed. In addition, carport in a house was ruptured and moved (Photo 6.5-9). The carport and the house was separated and moved about 50 cm due to the movement of the ground associated with liquefaction.

Photo 6.5-8 Tilted house

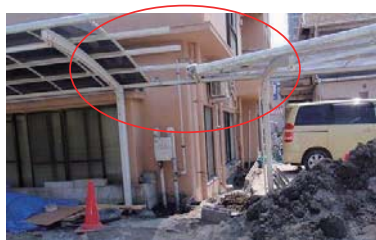
Photo 6.5-9 Moved carport

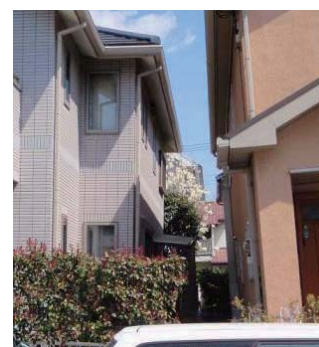
Significant tilting and subsidence of houses were observed at a zone in Benten (Photo 6.5-10). In another zone, the ground subsided by liquefaction, damage to the road that was waved and a 10 cm of difference in level was generated between a side ditch and the road. These types of damage were concentrated on an extension line of the boundary between the sites of tilted houses. Inhabitants told us that there was an old river on a straight line where the damage was concentrated.

Photo 6.5-10 Settled and tilted house

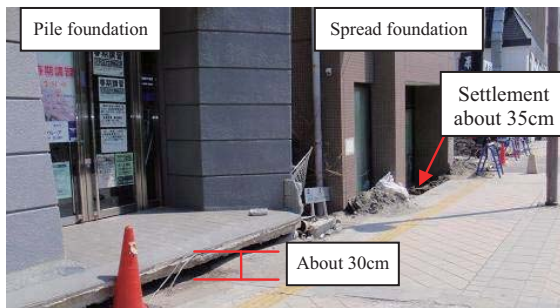
In Irifune, a difference in settlement between adjacent buildings on spread and pile foundations was observed. The building on spread foundation settled about 35 cm from the front sidewalk, while the case of building on pile foundation was about 30 cm of difference in level from the front sidewalk (Photo 6.5-11).

Photo 6.5-11 Difference in damage due to support mechanisms

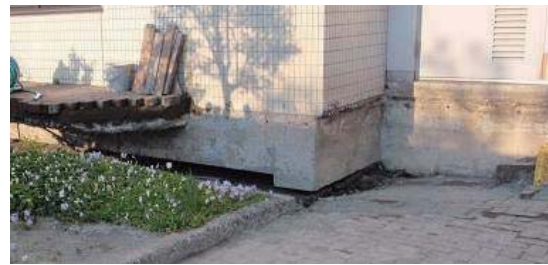
In Hinode, the ground subsidence was observed (Photo 6.5-12). This building is considered to have a pile foundation. A relative gap between the building and ground was about 50 cm. Building lifeline was damaged due to ground subsidence and displacement.

Photo 6.5-12 Building with subsidence of surrounding ground

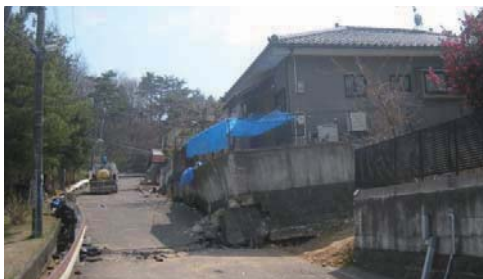
In one corner of a large-scale housing area, where a slope in the N-NE direction had been developed, ground deformation due to sliding of the reclaimed area by banking to the slope direction, and damage to the retaining walls due to ground deformation were often observed (Photo 6.5-13). Houses on the site were recognized to have different damage patterns, such as movement, subsidence and tilting without structural damage, severe structural deformation and fractured foundation.

Photo 6.5-13 Damage to retaining wall and house due to sliding and ground deformation

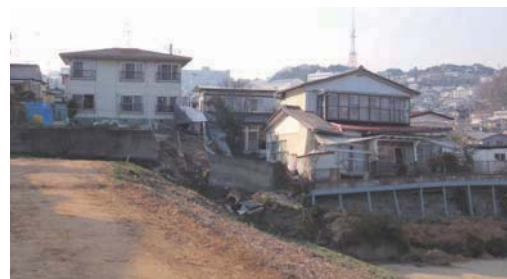
This area is located at one corner of the large-scale housing area where a hill was developed. Ground deformation due to sliding of the reclaimed area by banking to the slope direction, and damage to the retaining walls due to ground deformation, were often observed. The damaged area in 4-chome, Midorigaoka during the 2011 Tohoku earthquake was almost same as that during the 1978 Miyagi-oki earthquake. The land in 2-chome, Aoyama is wavier than in 4-chome, Midorigaoka. Near the zone of 2-chome, Aoyama, large-scale sliding of the embankment occurred (Photo 6.5-14). In this zone, large deformation and damage were seen on both of upper structures and foundations of houses in the housing area. In other places with embankment sliding, deformation and damage to upper structures of houses were observed, but it seemed that there was limited significant damage to foundations. In 2-chome, Aoyama, a retaining wall for the housing area with a height of over 5 m was damaged.

Photo 6.5-14 Group of houses damaged due to sliding and ground deformation

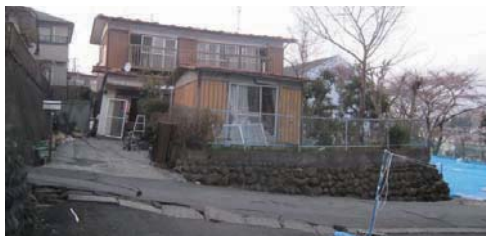
This area is located at one corner of a large-scale housing area where a slope in the eastern direction was developed. The area suffered ground deformation due to sliding of the reclaimed area by banking to the slope direction. Large structural deformation (Photo 6.5-15) was relatively often seen in houses in the area, but houses without structural damage were sporadically observed. In addition, a gap between the house foundation and surrounding ground that was caused by ground subsidence and transformation, and damage to the lifeline, were observed. Damage to a retaining wall in the area was hardly seen, while traces of flaking and falling of block fences on the upper part of the wall were sporadically observed.

Photo 6.5-15 Damage to houses due to sliding and ground deformation

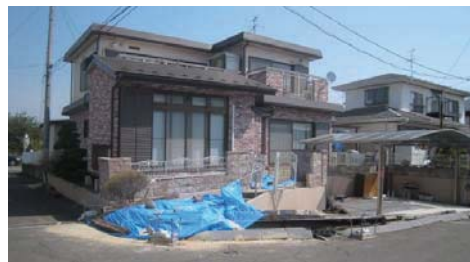
This is a housing area where a hill was developed. Fissures on the slope of the hill and near the top of the hill, and damage to housing foundations and retaining walls due to deformation of the reclaimed area by banking, were observed in the area. The slope in 1-chome, Midorigaoka had been significantly collapsed under the 1978 Miyagi-oki earthquake. A level of ground deformation on the slope under the 2011 Tohoku earthquake was lower than that during the 1978 earthquake. Near the top of the hill, ground deformation of the reclaimed area by banking caused fracture of the embankment retaining wall, damage to house foundations (Photo 6.5-16) and push-out of the retaining wall on embankment.

Photo 6.5-16 Houses damaged near the top of hill

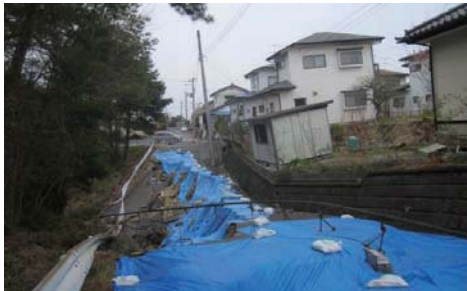
This is a housing area where a hill was developed. Land sliding of the slope at the end of the hill, and ground deformation that seemed to be related with the sliding were observed. This ground deformation caused serious damage to houses. In the result, some houses were in a state of sliding on the slope of the hill (Photo 6.5-17). On the other hand, there was no ground deformation in a house located in the flat part of the hill, while paper sliding doors on the first-story of the house were only broken during the earthquake.

Photo 6.5-17 Fracture of embankment retaining wall and houses tilting due to land sliding on the slope of hill end

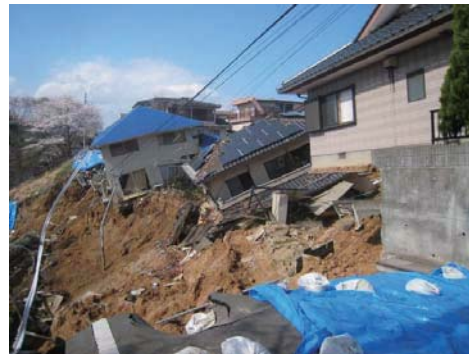
This area is located at one corner of a large-scale housing area where a hill was developed. The result of investigation was revealed ground deformation due to land sliding on the slope of the hill. This ground deformation caused serious damage to houses. In the result, several houses were in a state of sliding on the slope of the hill (Photo 6.5-18). On the other hand, houses near the top of the hill suffered only damage associated with slight deformation of the reclaimed area by banking.

Photo 6.5-18 Land sliding of slope on the southwest of hill and sliding houses
