## **7. Damage to Buildings in Inundation Areas Induced by Tsunami**

### **7.1 Introduction**

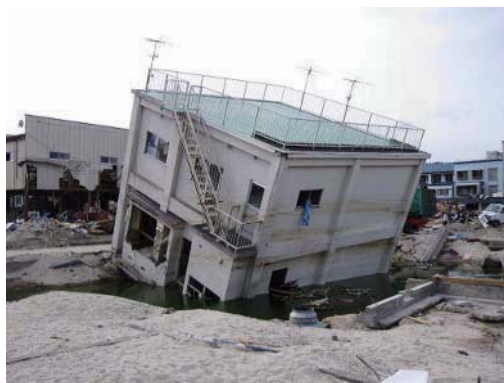
When tsunami acted on a building, a strong stream was generated around the corner of the building, resulting in many large holes on the ground that were bored by scouring. In one case, a building on mat foundation fell into a hole bored by scouring (Photo 7.2-4).

Photo 7.2-4 A 2-story reinforced concrete building that was tilted by scouring

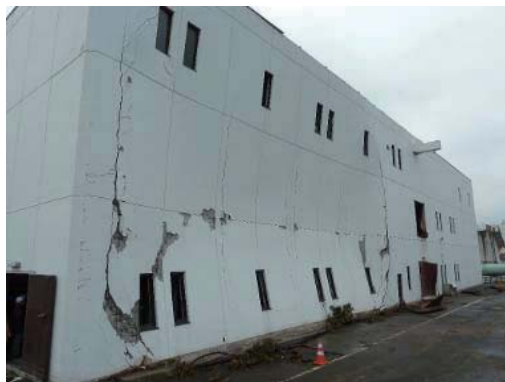
Cases that such wall reinforcement was fractured were often seen in wall members with single layer bar arrangement. In one damaged building (Photo 7.2-5), a 300 mm-thick shear wall with double layer bar arrangement and a support span of more than 10 m and without the second and third floor slabs was bent inside by tsunami wave pressure. However, a shear wall in an area (Photo 7.2-5 Back of the building, right-hand side), where there was a floor on the second story and a support span was not long in the same building, was not bent.

Photo 7.2-5 Out-of-plane fracture of reinforced concrete shear wall without floor

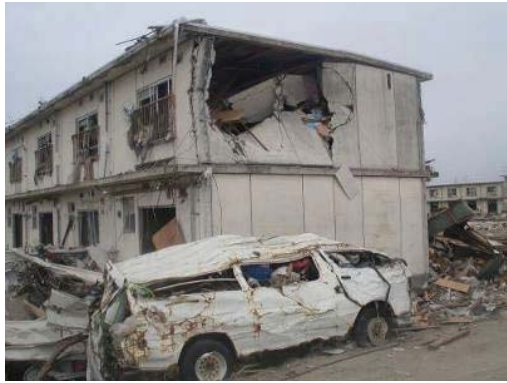
Debris impact was seen in most of the non-structural members such as window and ceiling materials. The number of cases of clear damage to skeletons was not large, but in one observed case, a multi-story wall in an apartment house was probably bored by debris impact (Photo 7.2-6).

Photo 7.2-6 Wall opening probably generated by debris impact

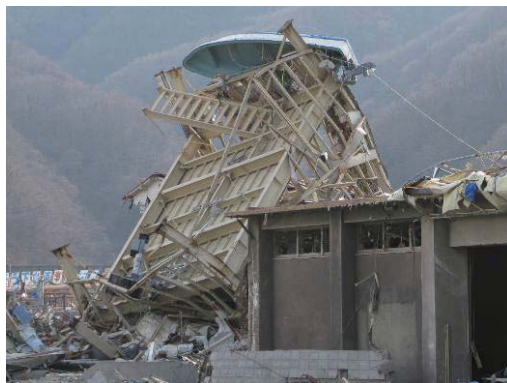
A typical case of building movement and washout was that a building moved and flew due to the fracture of anchor bolts and/or base plates at steel exposed column bases and the fracture of a weld between the column and the base plate (Photo 7.2-7). In most cases, foundation and some column bases were left in the site, but the upper structure of the building was moved beyond the site or missing.

Photo 7.2-7 Steel building overturned by fracture of column base anchor bolts

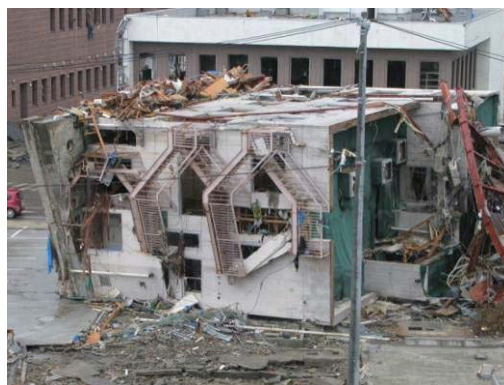
One case that a whole building including foundation was overturned, was confirmed. Most of the AAC panels of claddings were left (Photo 7.2-9).

Photo 7.2-9 Overturning of a 3-story steel building

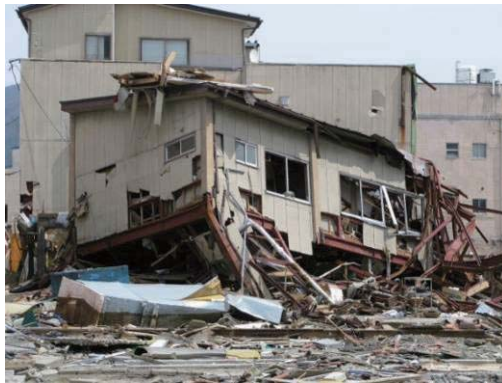
Skeleton collapse including story collapse of the first floor was seen in a 2-story steel building (Photo 7.2-10). Partial collapse of a warehouse was also seen on the coast.

Photo 7.2-10 Story collapse of first floor in a 2-story steel building

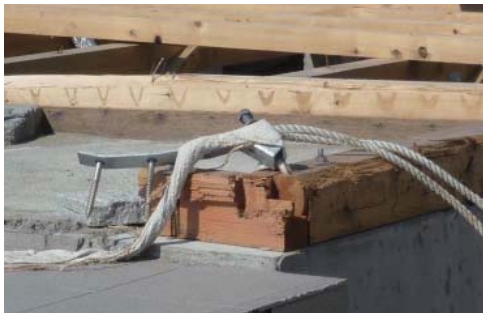
Photo.7.4-5. Failed hold down fastener.

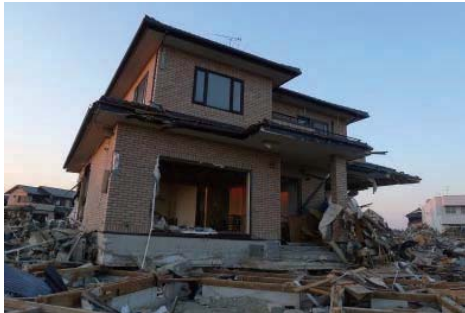
Wood buildings also suffered crushing damage due to tsunami, as shown in Fig. 7.4-2. The parts of buildings remained, for example foundation, sill, and so on, were as same as mentioned in (1). Figures in rectangles in Fig. 7.4-2 show the locations of buildings mentioned in the followings. The wood house (Photo 7.4-10:①) united with the foundation and carried away. In the original position of it, steel tube piles remained as shown in Photo 7.4-11(②). Because a temple building (Photo 7.4-12:③) and a steel-frame house (④) were damaged heavily and remained, tsunami wave force was reduced to some extent, and the neighboring wood house with store avoided being carried away, as shown in Photo 7.4-13 (⑤). It might be possible for the survived low-rise building to make wave force reduce.

Photo 7.4-10. Wood house (1) that was carried away with the base in Yuriage, Natori city.

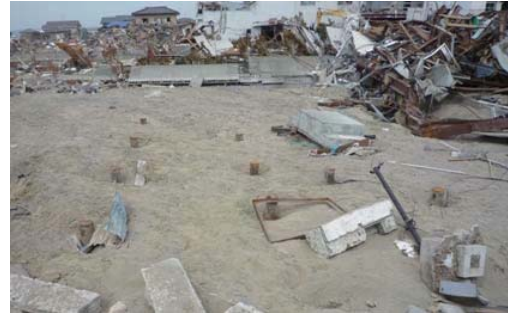
Photo 7.4-11. Steel tube pile left at the the original position (2) of house in photo 7.4-10.

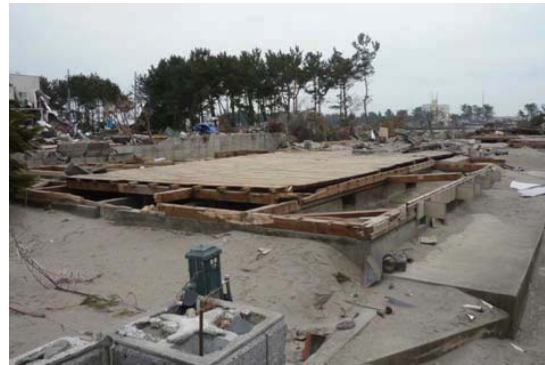
In the south east of Hiroura bridge (⑥), there was protect forest (Photo 7.4-14:⑦) of the pine trees with about 20 cm diameter at breast-height. The water depth was estimated to be about 5-6 m by the flotsam attaching to trees. A part of this protect forest fell down completely, in the downstream of this, the wood house (Photo 7.4-15:⑧) was washed away. On the other hand, in the downstream of survived protect forest, wood houses were selectively carried away and an example of the remained house was shown in Photo 7.4.16 (⑨). It seems to be generally thought that protect forest reduces wave force. However, because it cannot be thought that the strength of trees falling down continually was quite different by their location, it would be natural to think that the wave force or the speed of

Photo 7.4-15. Fallen Protect forest and wood house (8) washed away in Yuriage, Natori city.

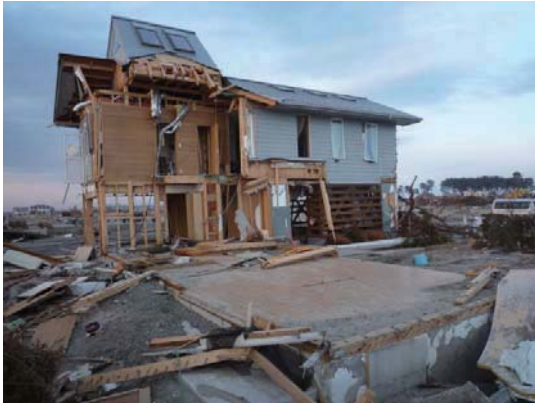
In the area between Pacific Ocean and Arahama port, remained wood buildings were Glulam frame structure (Photo 7.4-22) and a mixed structure (Photo 7.4-23) which has 1<sup>st</sup> story of RC structure and wooden 2<sup>nd</sup> story. In other cases, the part of the L-shaped wood house (Photo 7.4-24) whose part with short horizontal length in the direction of wave pressure was washed away, and another part with long horizontal length remained. It was confirmed that metal fasteners were used in the column end joints, and considered that the

Photo 7.4-24. L-shaped wood house whose part was washed away in the east of Arahama port.

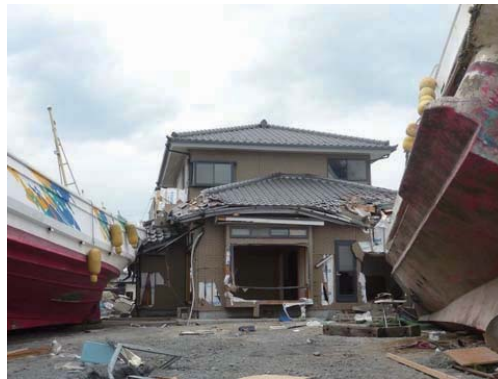
In the west area of the Arahama port, it was confirmed that the wood house (Photo 7.4-26) was crashed by two ships but remained. The reason was that the wave pressure was low and the structural performance of the house was high because the house was relatively new.

Photo 7.4-26. Wood house remained in spite of ships' crashing in the west of Arahama port.

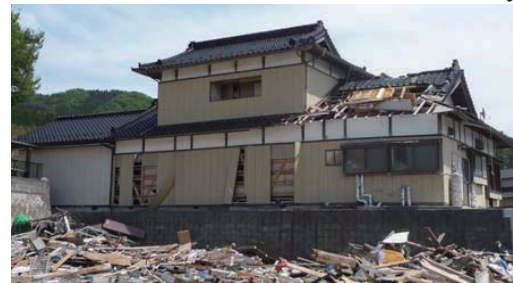
failure of walls. Close to this house, a wood house (Photo 7.4-30:6) remained under about 6 m water depth in spite of partial failure in the roof system. It was considered that this failure caused by the floating materials. There was a house (7) remained in the next, but a house which was guessed to have many hold down fasteners (8) was washed away. The house with hold down fastener may not remain by severe tsunami.

Photo 7.4-30. Wood house (6) which was not carried away in spite of damage on 1<sup>st</sup> floor roof system in Akasaki-cho, Oofunato city.

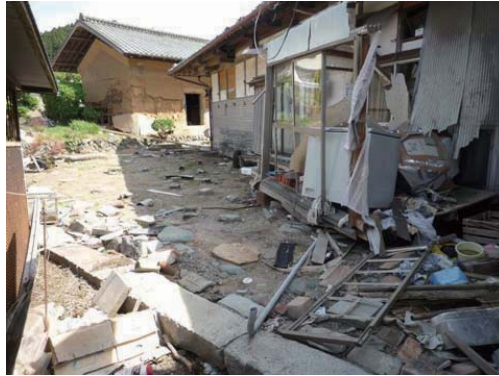
Photo 7.4-33. Survived old house (12) which rotated and moved horizontally in Akasaki-cho, Oofunato city.
