**International Platform for Reducing Earthquake Disasters (IPRED)**  
 26~28-07-2011 UNESCO-IPRED 4th Workshop, in Santiago, CHILE

## Lessons Learnt from the Recent Off the Pacific Coast of Tohoku Earthquake in Japan

**Building Research Institute**

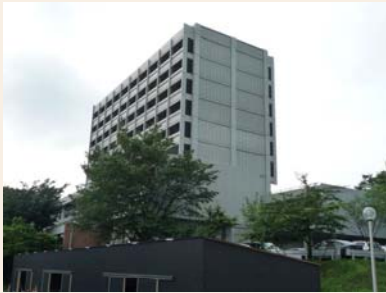
# Nine-story school building of Tohoku Univ., Sendai

Lessons:  
We could observe a damage process of the building. It leads to  
1) Application to health monitoring.  
2) Testing of non-linear response analysis method.

Temporal change of national period of the building.

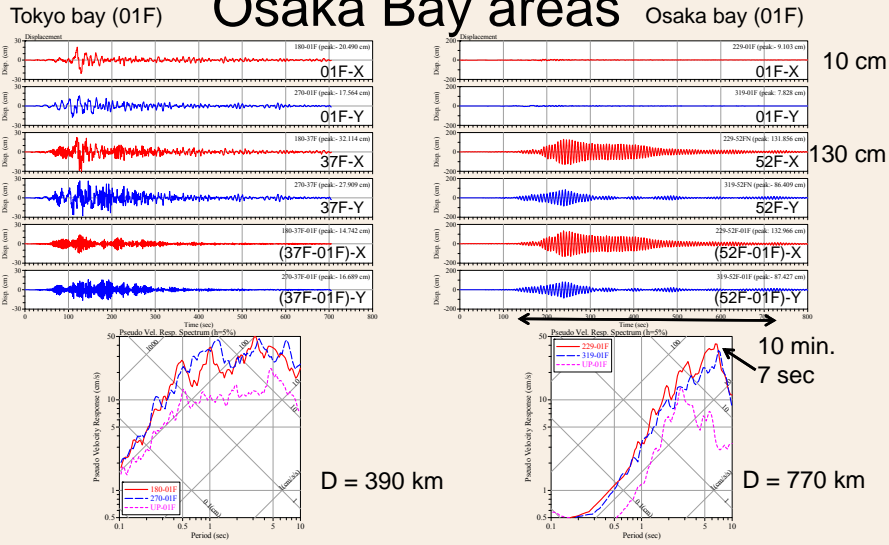
# Long-period motions in Tokyo and Osaka Bay areas

Lessons: Resonance, Damping, Health Monitoring → To be retrofitted 9

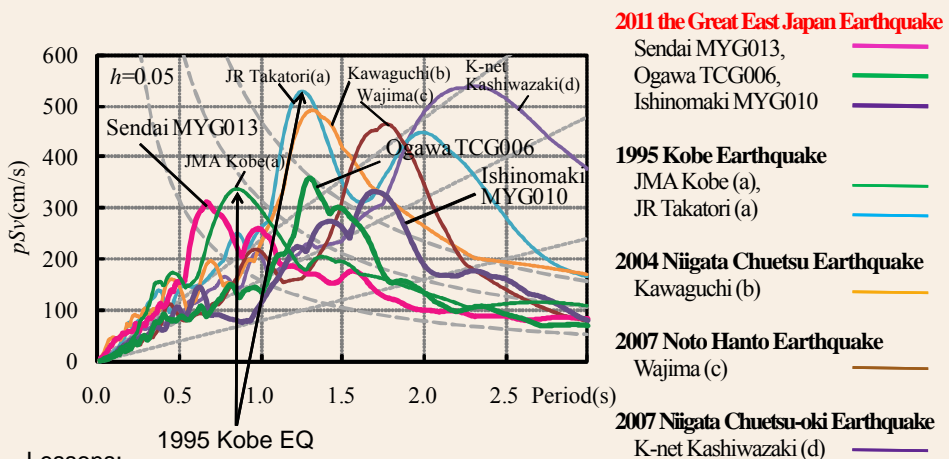
## Analysis of Seismic Response Properties (Comparison with the past records using Pseudo-velocity response spectrum)

Lessons:  
 Building damage was caused by strong 1.0 – 1.5 s seismic waves mainly.  
 The Kobe EQ caused much severe damage than the Tohoku EQ.

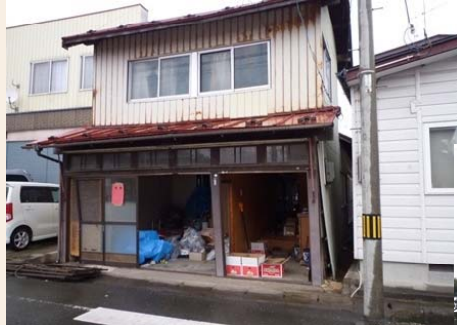
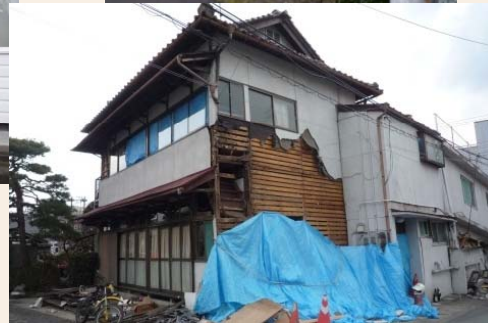
- Damage to Timber Structure

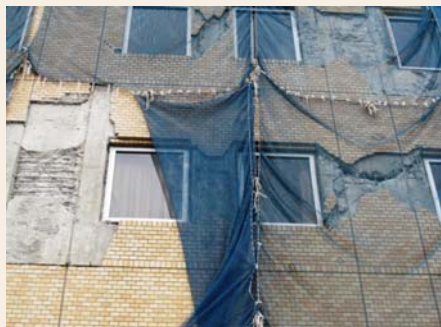
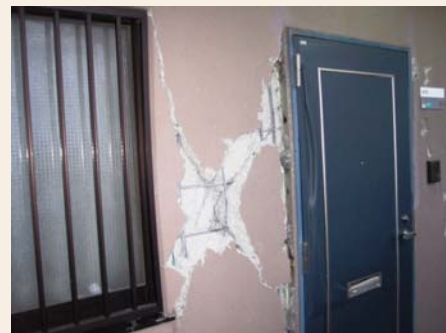
- Damage to RC Structure

- Cracks in columns and exterior walls

- Shear failure of non-structural wall next to entrance

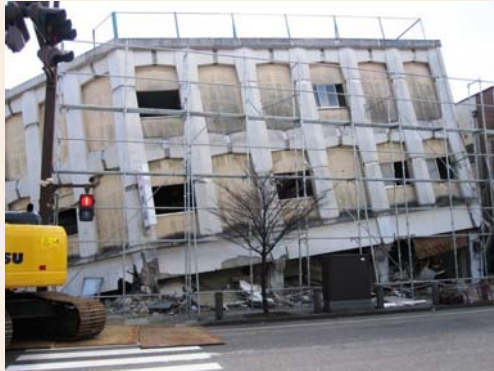
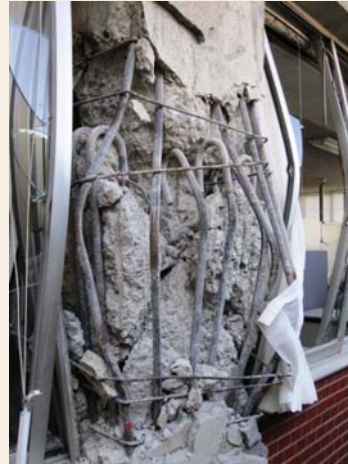
- Damage to RC Structure

- 1<sup>st</sup> story of 3 storied RC building was collapsed. Front side is frame structure and back side is frame with wall structure.

- Shear failure in columns on 1<sup>st</sup> story of 4 storied RC building which shows 180 degree hooks of main bars.

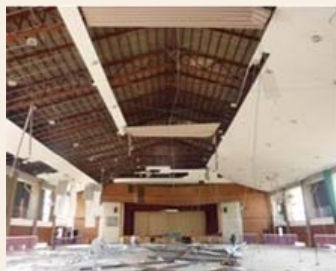
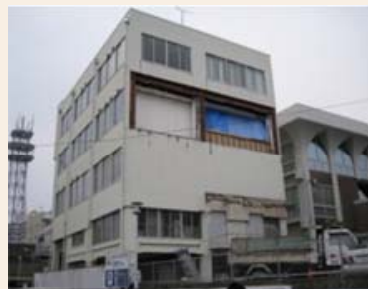
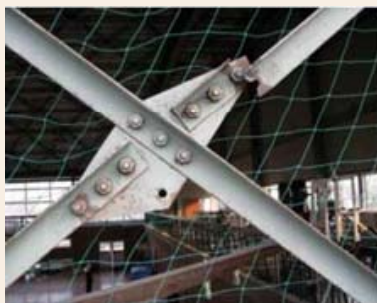
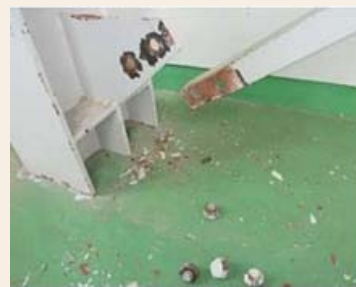
- Damage to Steel Structure and Non-Structural Elements

- **Damage to buildings is not so severe whereas the seismic intensities were high** and the disaster areas were extended to extremely large.
- **Timber Structure** : Typical seismic damage was observed.
- **RC Structure** : Significant difference appears between before and after the **new seismic design code (1981)**. Typical seismic damage was observed.
- **Steel Structure** : Damage to vertical / horizontal braces and joints was observed.
- **Non-structural Elements** : The fall of exterior walls, suspended ceilings in large-scale spaces, and interior materials were observed.
- Damage occurred in some grounds of developed residential areas and sloping areas.
- The severe **liquefaction** damage occurred in very wide areas.

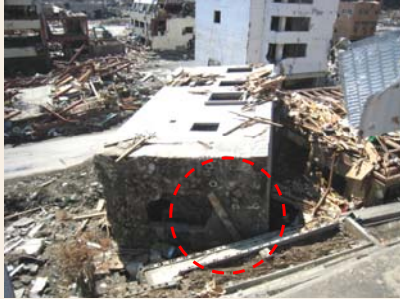
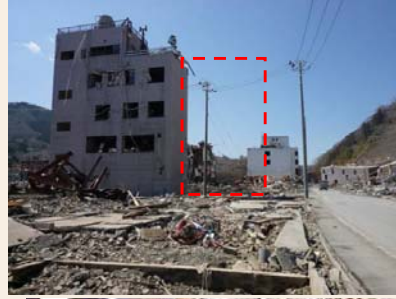
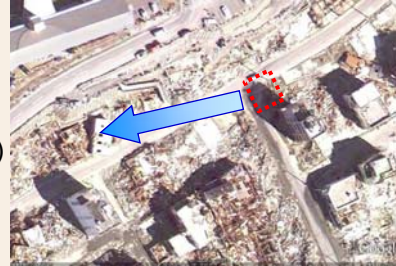
• **Damage to RC Structure**  
**Buildings swept-away and fallen-over**

4-story frame with shear wall structure  
 Pile foundation (pulled-out, ruptured)  
 Few Openings  
 Swept-away (70 m, no traces of dragged)  
 Fallen-over  
 Distance from the coast: ~200 m  
 Depth of inundation: ~15 m

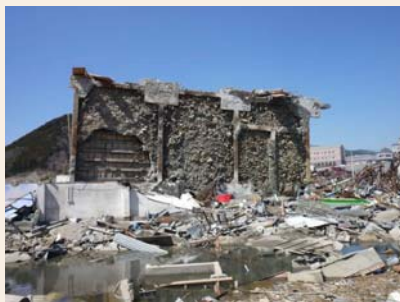
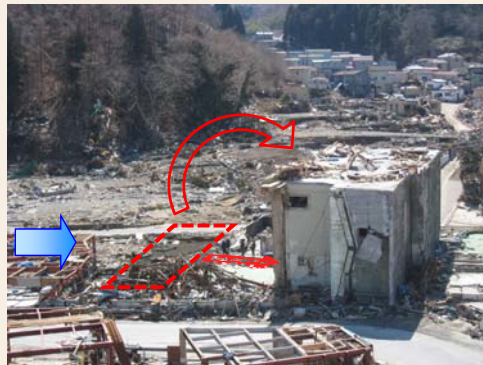
• **Damage to RC Structure**  
**Buildings swept-away and fallen-over**

2-story frame structure  
 (refrigerators)  
 Few openings  
 Swept-away and fallen-over

Distance from the coast: ~200 m  
 Depth of inundation: Over 6.5 m

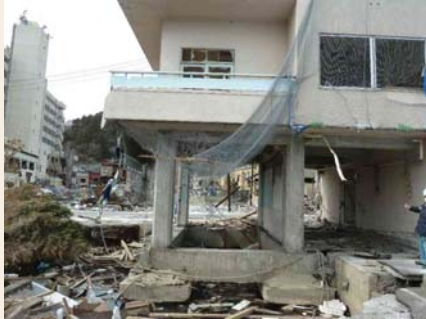
4 storied RC frame building

- Soil flowed away by tsunami.
- Photo shows the footing basement under columns.

- Out of plane collapse of exterior wall with frame and without inside floor.
- The right side of photo shows no collapse of wall with floor.

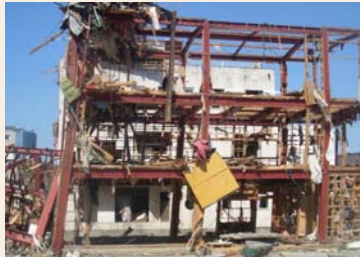
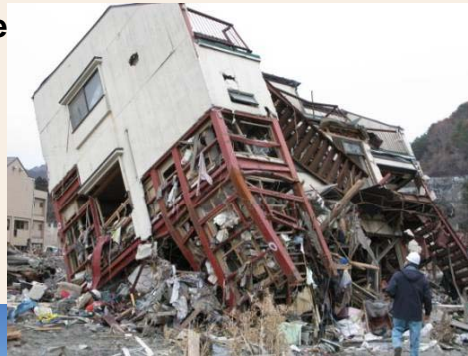
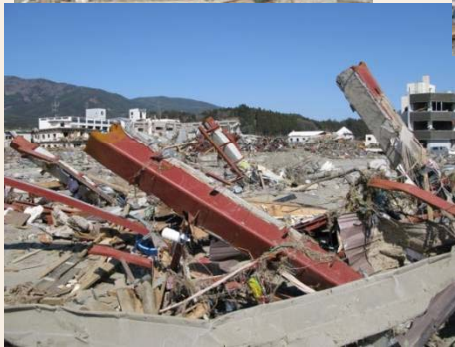
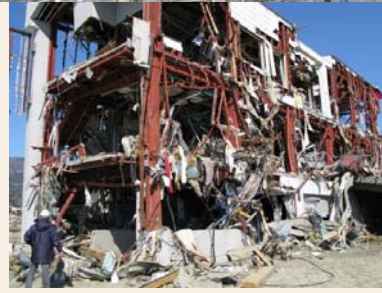
• **Damage to Steel Structure**

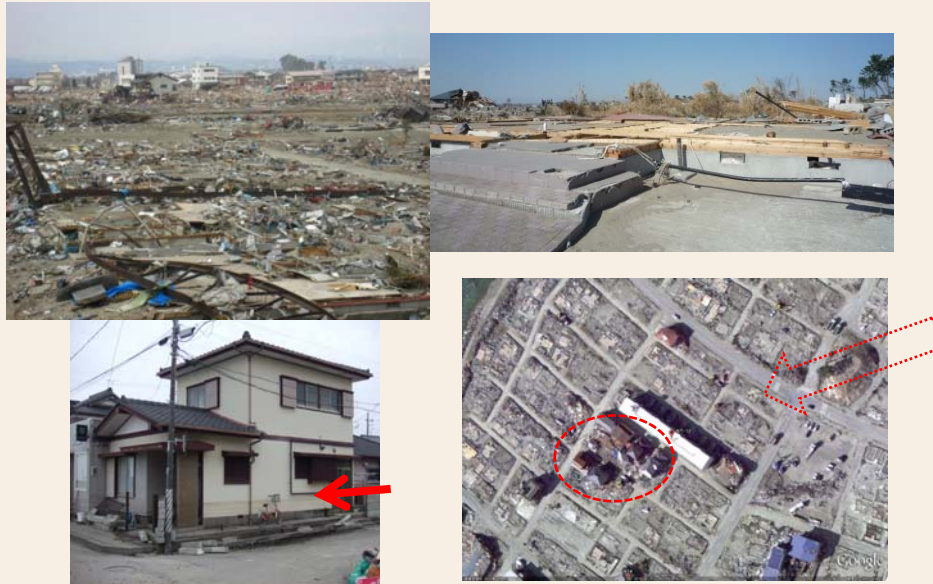
• **Damage to Timber Structure**

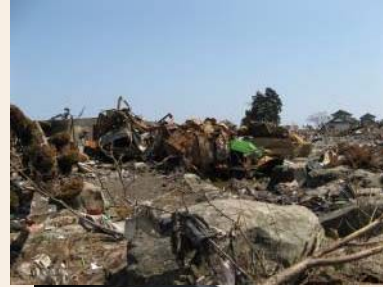
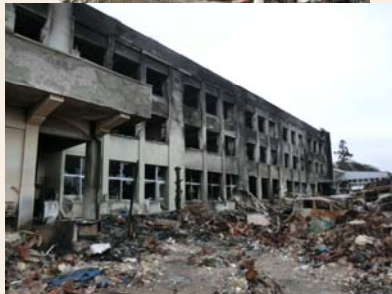
- Grasping the damage state of large-scale fire and fire in buildings caused by the earthquake and the following tsunami in cooperation with other institutes and universities

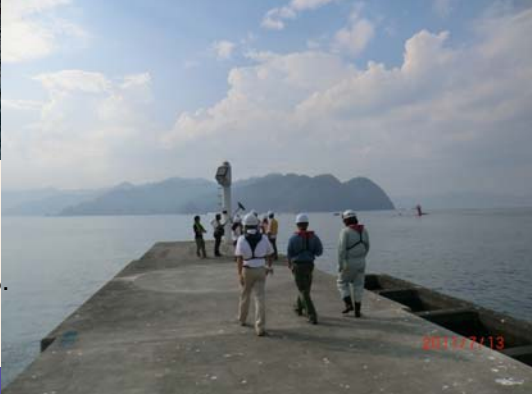
### World largest break water in Kamaishi Port

1,660 m long & 63 m height

1/3 collapsed, but  
Tsunami height was reduced 40 %.  
Arrival time delayed 6 min.  
(Kamaishi Port Office)
