6. Damage to Buildings by Earthquake Motions

6.1 Policy on Earthquake Damage Investigation for Buildings

6.2 Damage to Wood Houses

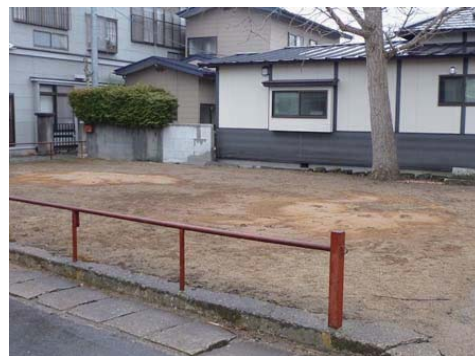
Photo 6.2-2 Sand boil due to liquefaction

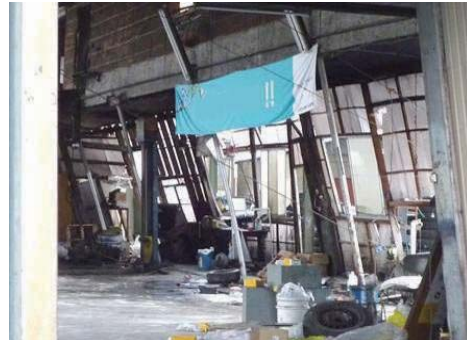
A large residual deformation was observed in the longitudinal direction in the large-scale wood building used as a movie theatre then renovated to a factory (Photos 6.2-5, 6.2-6)

Photo 6.2-6 Inside of the building shown in Photo 6.2-5

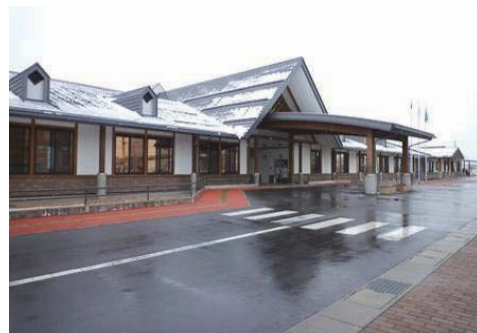
The Seismograph of Kurikoma (JMA seismic intensity 6-) is set up on the parking lot in the west of “Michinoku-Densokan (Photo 6.2-9) ”. From the exterior damage investigation, damage was not observed in “Michinoku-Densokan” and Kurikoma Branch office (Glulam frame structure: Photo 6.2-10).

Photo 6.2-10 Kurikoma Branch office (Glulam frame structure)

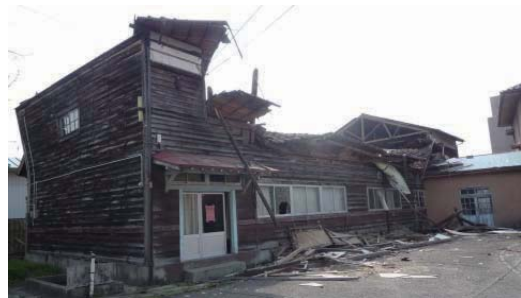
Photo 6.2-18 School building whose 2nd story collapsed

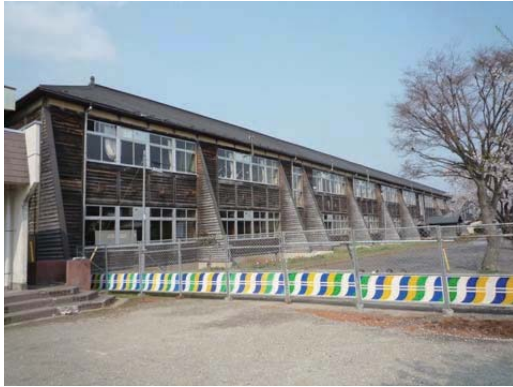
Photo 6.2-19 Seemingly slightly damaged School building

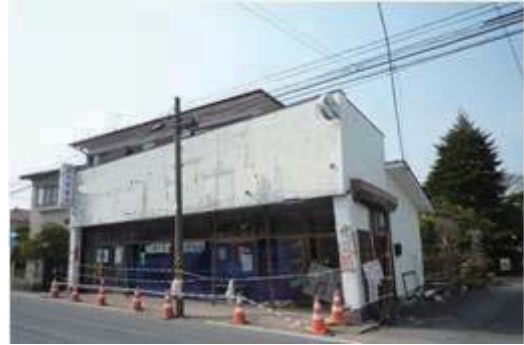
Photo 6.2-20 House with store with large story deformation

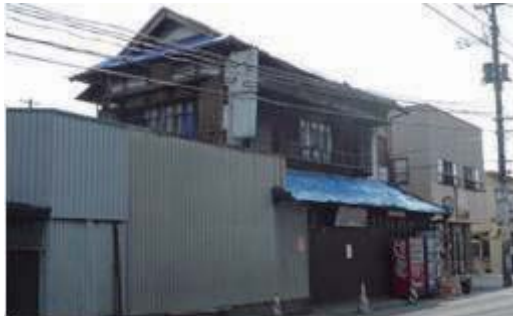
Photo 6.2-21 House with store with 2nd story drift more than that of 1st story

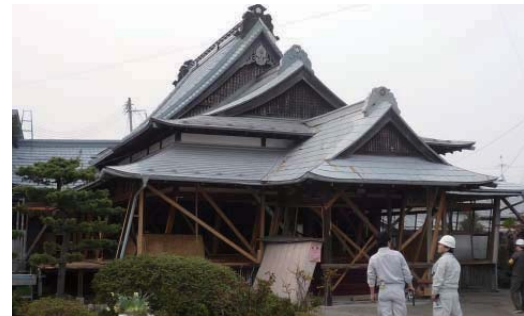
In the northwest of JR Freight Company Furukawa Station, a collapsed steel frame building, an RC structure apartment house with rocking drift caused by the land deformation, and a temple building (Photo 6.2-22) with large story deformation were observed.

Photo 6.2-22 Heavily damaged temple building

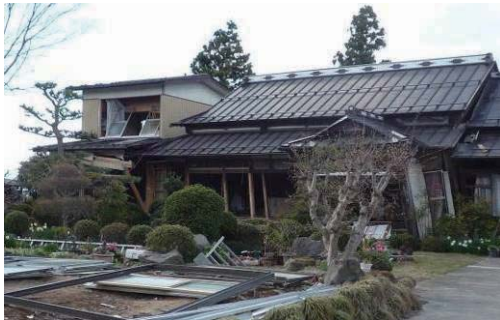
Photo 6.2-23 Largely tilted house

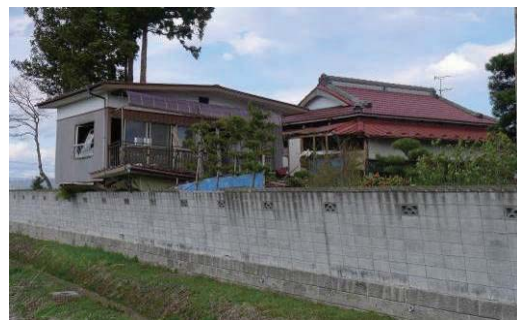
Photo 6.2-24 Collapsed wood house

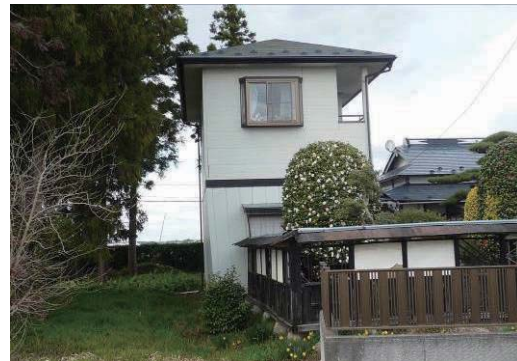
Photo 6.2-26 Tilted two-story house

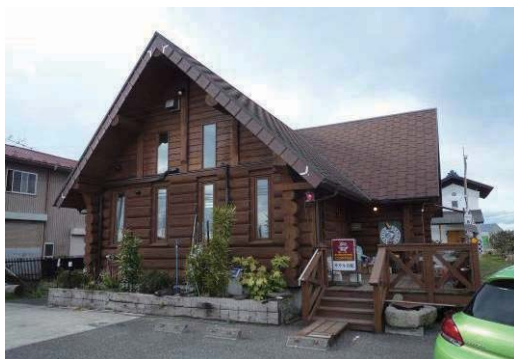
which two-story might have been extended. In the southern side of Eaigawa river, there were log house without damage (Photo 6.2-27), wood house which tilted largely at first story (Photo 6.2-28) and tilted shrine building (Photo 6.2-29).

Photo 6.2-27 Log house without damage

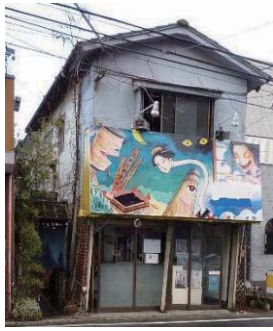
Photo 6.2-41 House with large residual deformation (Komatsujima)

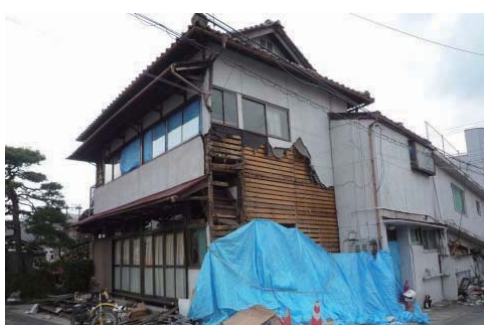
A lot of damaged wood houses were observed around the collapsed RC structure building. Examples are as follows: the failed exterior mortar wall of the 2nd floor in a house with store (Photo 6.2-44), deterioration and damage by *Reticulitermes* on a part of structural member and wood lath of exterior mortar wall (Photo 6.2-45), a wood house whose stair hall was removed and collapsed (Photo 6.2-46), and so on.

Photo 6.2-46 Collapsed stair hall

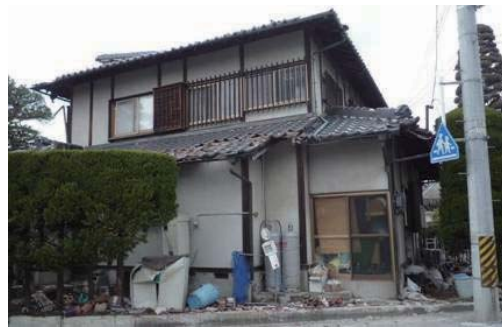
Photo 6.2-49 Damage of roof tile

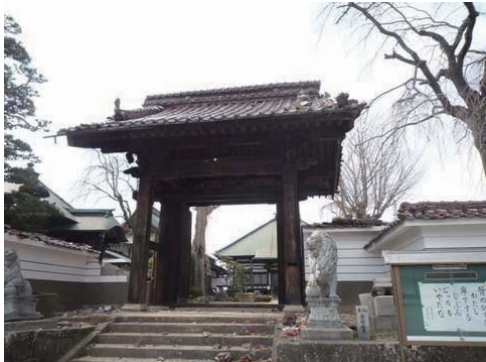
The wood warehouses with mud wall were heavily damaged near the hotel with the window glass broken. For example, the warehouses which deformed much (Photo 6.2-47) and whose roof system collapsed (Photo 6.2-48) were observed. A few wood houses with roof tiles damaged (*e.g.* Photo 6.2-49) were found. On the other hand, roof tiles of temple gate (called as “*Sanmon*”) were damaged, while the main hall of the

Photo 6.2-50 Minor damage of temple gate

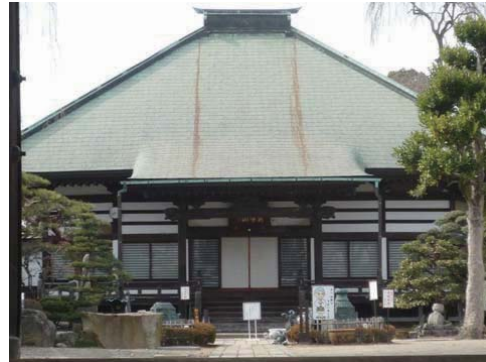
Photo 6.2-51 No damage on main hall of temple

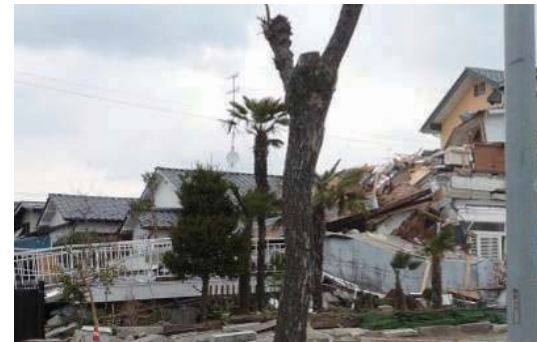
Another collapsed building with uncertain structural type was found (Photo 6.2-53). According to the damage overview seen from the east of Minami-machi (Photo 6.2-54), it was observed that the wood houses with roof covered temporarily with blue vinyl sheet which was guessed to be damaged to roof tiles were relatively many.

Photo 6.2-53 Collapsed building (Unknown structure type)

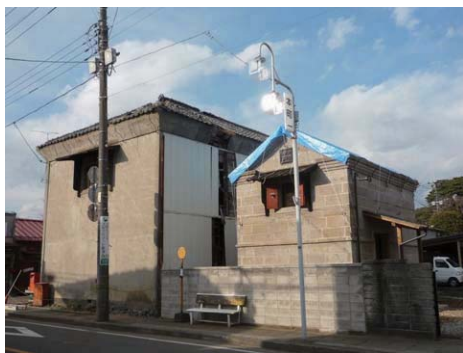
The stone-built warehouse was heavily damaged near the town office (Photo 6.2-55). The exterior stonewall of the former post office was failed (Photo 6.2-56).

Photo 6.2-55 Damage of stone-built warehouses

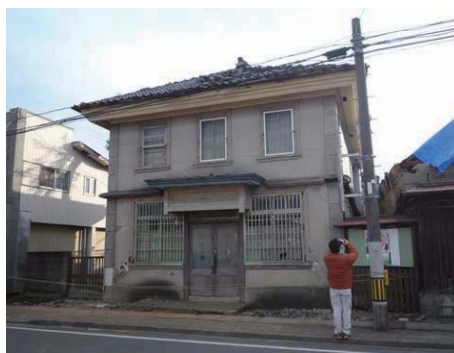
Photo 6.2-56 Damage of an old post office

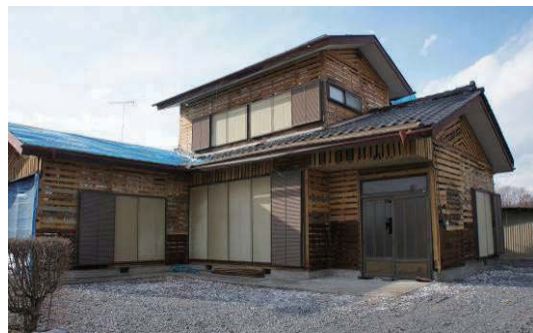
In Nishi-Ohkubo area, several wood houses whose exterior mortar wall in the 1st floor was almost failed were found (Photo 6.2-62). And, the wood house with large story drift (Photo 6.2-63) and the other one damaged due to deformation of the residential land (Photo 6.2-64) were found.

Photo 6.2-62 Damage of exterior mortar wall

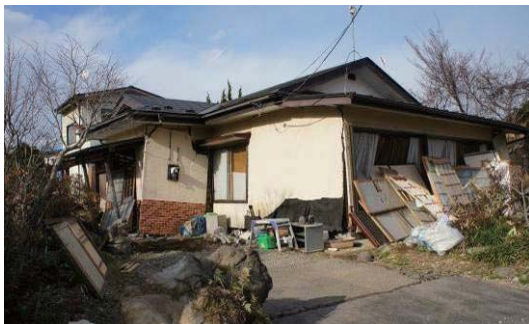
Photo 6.2-63 Wood house with large story drift

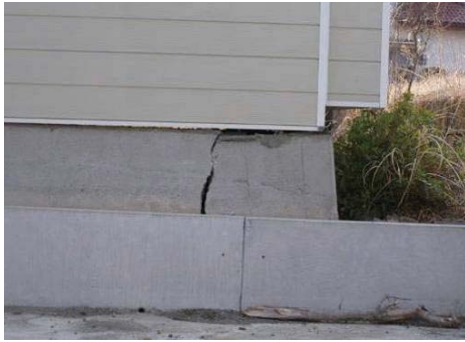
Photo 6.2-67 Crack of foundation

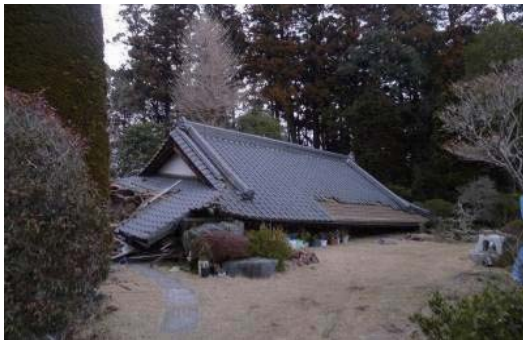
There were a lot of damaged fence made by the Ohyaishi stone. A collapsed farm type house was observed (Photo 6.2-69, 6.2-70). The mortar plastered wall finish of the wood house at the land filled paddy field fell down (Photo 6.2-71).

Photo 6.2-69 Collapsed wood house

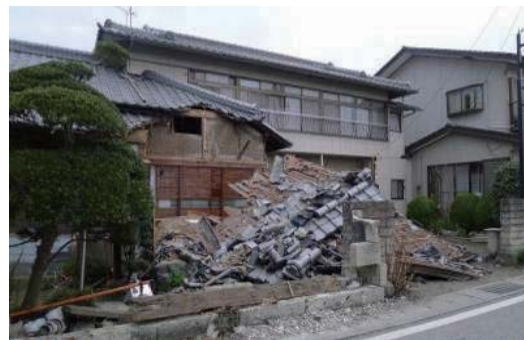
Photo 6.2-70 Breakage of entrance part.

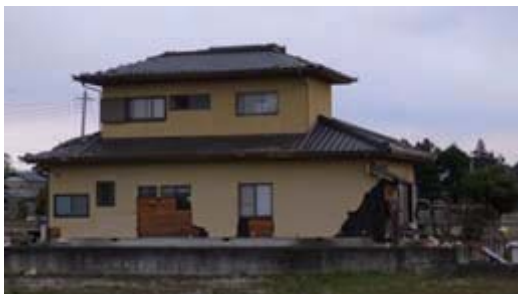
Photo 6.2-71 Falling down of mortar plastered wall

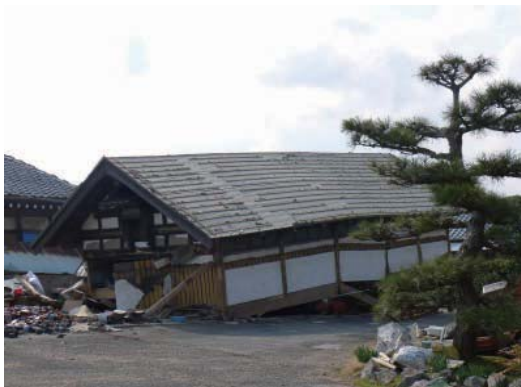
At Kadobe-shimogawara in Naka city, there were a lot of collapsed barns (Photo 6.2-72) and heavily damaged nagayamon gates (Photo 6.2-73). A damaged house with store was observed (Photo 6.2-74). A lot of collapsed barns were observed at Kadobe-akutsu.

Photo 6.2-72 Collapsed nagayamon gate (Kadobe)

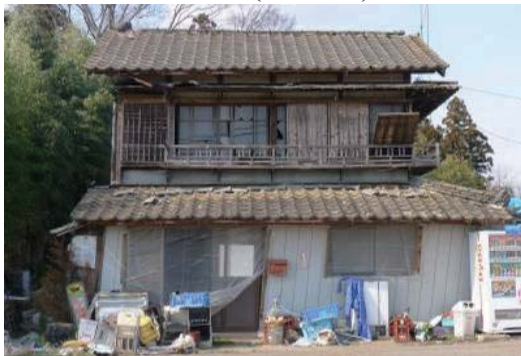
Photo 6.2-74 Damaged house with store (Kadobe)

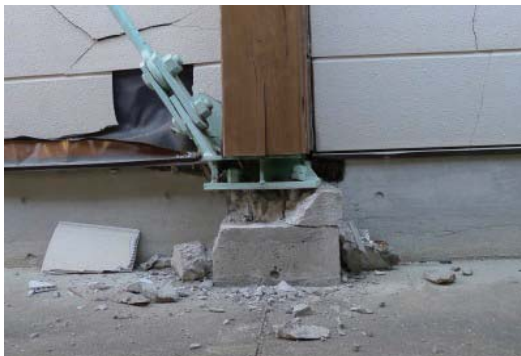
At the wood gymnasium (Photo 6.2-76, Photo 6.2-77) with curved glue laminated timber built in 1985-1989 in Urizura, buckling and tensile failure of the steel braces, the breakages of the foundation concrete at the brace joint were observed (Photo 6.2-78). At the wood school building (Photo 6.2-79), the slip of wood braces (Photo 6.2-80), the deformation of steel roof plate, wood flooring and interior material due to the contact with the stairway made by reinforced concrete were observed.

Photo 6.2-78 Breakage of the foundation concrete

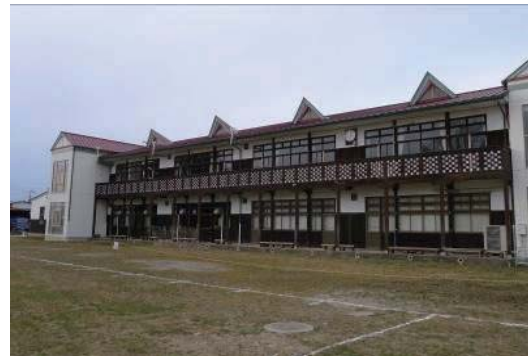
Photo 6.2-79 Wood school building

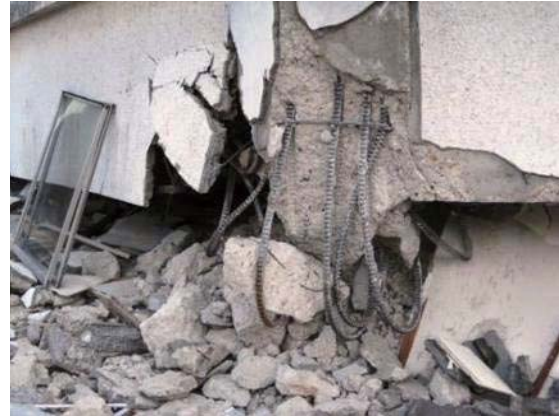
A three-story RC building shown in Photo 6.3-4 was severely damaged on the first story, which was located at the intersection in Sukagawa city, had a few walls on the facade on the first story and many walls on the back of the first story and the second story and higher. The corner columns faced to the intersection were significantly destroyed as shown in Photo 6.3-5. The loss of axial load carrying capacity of the first-story columns caused the drop of the second and higher stories.

Photo 6.3-5 Close-up view of the fallen story

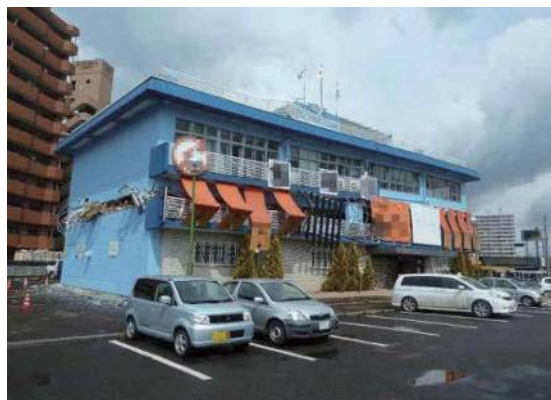
A three-story office building shown in Photo 6.3-6 in Wakabayashi ward, Sendai city partially collapsed on the second story and the building tilted. Only the second story has openings on the wall at the gable side, as shown in the left of Photo 6.3-6. For this reason, it was assumed that the openings were intensively deformed and resulted in shear failure of the short columns formed by the hanging and spandrel walls. The shear failure of the long columns on the third story was observed possibly due to the effect of the collapse of the second story. The damage to the columns and beams on the first story was not seen, while shear cracks were observed on the nonstructural walls.

Photo 6.3-6 Mid-story collapsed building (Wakabayashi ward, Sendai city)

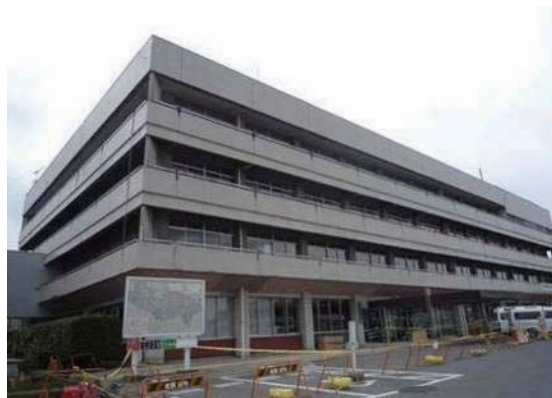
Photo 6.3-14 shows the four-story RC building that was constructed in 1970 in Sukagawa city. The columns with the spandrel wall on the first story were heavily damaged in shear and shorten in the axial direction as shown in Photo 6.3-15. The same damage was observed on the second-story exterior columns. Some of the reinforcing bars of the damaged columns that were raised from the foundation were anchored with a 180-degree hook near the mid height of story. It is considered that the shear failure began at this point. Two shear walls were severely damaged, which were arranged in the center core of the building to resist mainly horizontal forces. In particular, the second-story core wall was failed in shear in both of the span and longitudinal directions, and the longitudinal reinforcements in the boundary column of shear wall were heavily buckled as shown in Photo 6.3-16.

Photo 6.3-14 Appearance of damaged building (Sukagawa city)

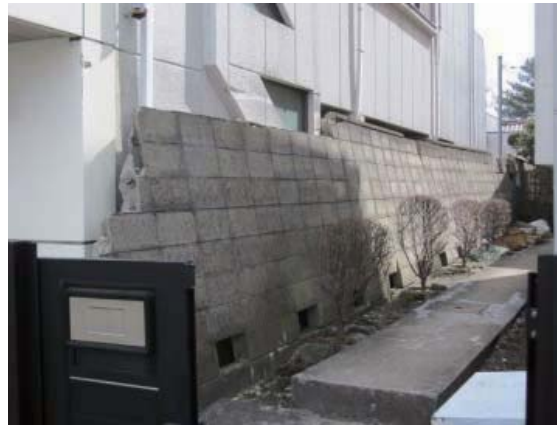
Photo 6.3-51 Collapse of concrete block wall (Sukagawa city)

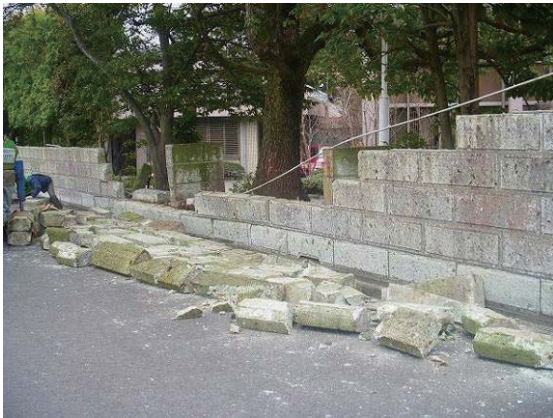
Photo 6.3-52 Collapse of stone masonry wall (Fukushima city)

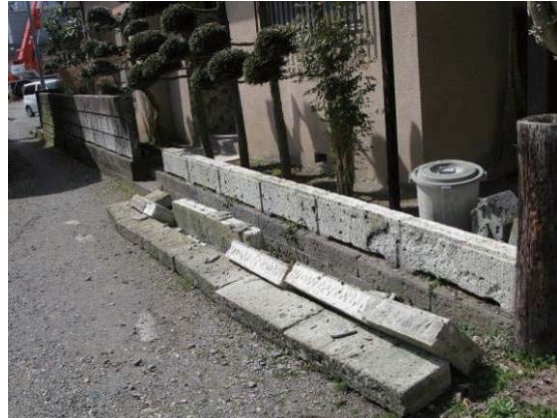
Photo 6.3-53 Collapse of stone masonry wall (Shirakawa city)

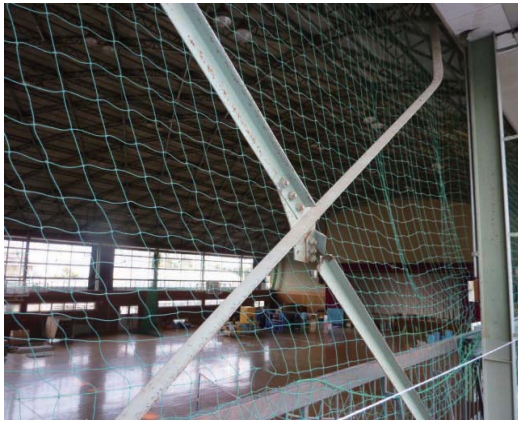
Buckling of brace member (Photo 6.4-1) and fracture of brace joint (Photos 6.4-2 ~ 6.4-4) were observed. Angle section was often used for many brace members, but circular hollow section steel (Photo 6.4-3) was also used for brace members. Fractured sections include steel plate inserted into steel pipe, end of bracing member and section loss part by bolt hole. These types of the damage are classified into the severe damage category based on the damage evaluation standard^{6.4-4)}. The number of the gymnasiums of this type is 3. The gymnasiums constructed under the previous seismic code that had been severely damaged by the Mid Niigata Prefecture Earthquake in 2004 had accounted for about 30% of the total^{6.4-1)~6.4-3)}. It is impressed that a rate of the gymnasiums severely damaged by the 2011 Tohoku earthquake was lower than by the Mid Niigata Prefecture Earthquake in 2004.

Photo 6.4-1 Buckling of brace

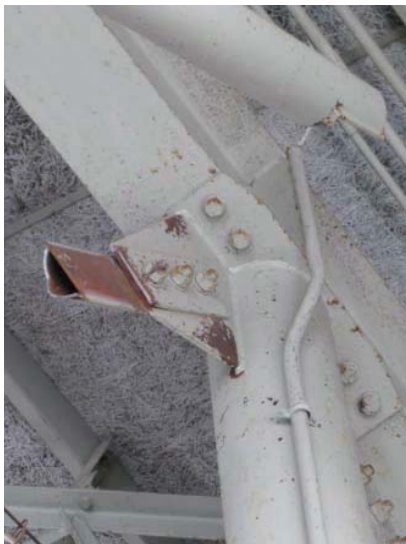
(a) Fracture at column top

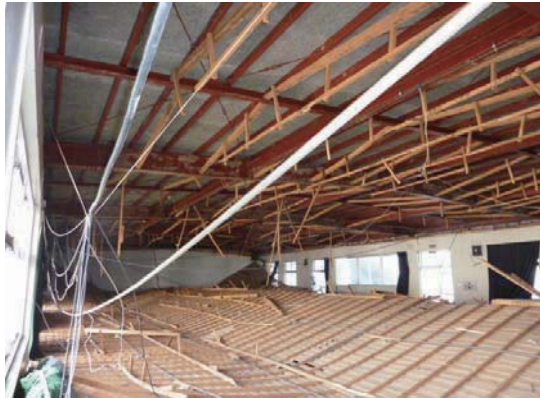
Photo 6.4-17 Dropping of extensive ceiling components

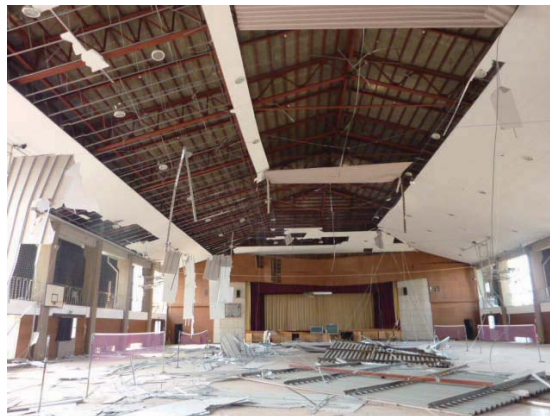
Photo 6.4-18 Dropping of extensive ceiling components

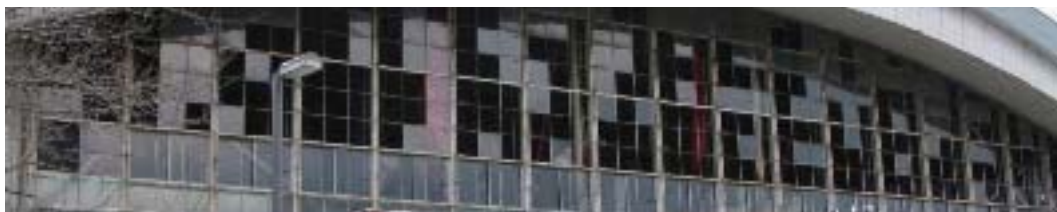
Photo 6.4-19 Breakage of windows

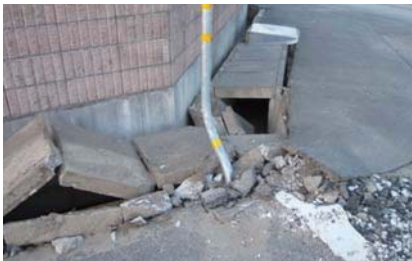
Photo 6.5-6 Damage to side ditch

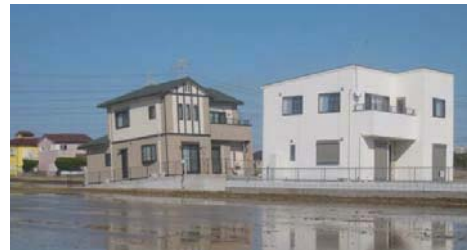
Photo 6.5-7 Damage situations by liquefaction

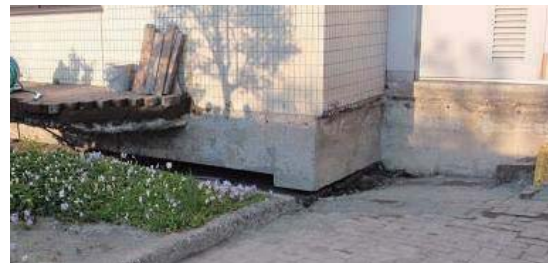
In Hinode, the ground subsidence was observed (Photo 6.5-12). This building is considered to have a pile foundation. A relative gap between the building and ground was about 50 cm. Building lifeline was damaged due to ground subsidence and displacement.

Photo 6.5-12 Building with subsidence of surrounding ground

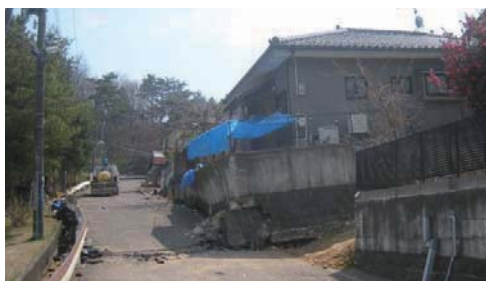
This area is located at one corner of the large-scale housing area where a hill was developed. Ground deformation due to sliding of the reclaimed area by banking to the slope direction, and damage to the retaining walls due to ground deformation, were often observed. The damaged area in 4-chome, Midorigaoka during the 2011 Tohoku earthquake was almost same as that during the 1978 Miyagi-oki earthquake. The land in 2-chome, Aoyama is wavier than in 4-chome, Midorigaoka. Near the zone of 2-chome, Aoyama, large-scale sliding of the embankment occurred (Photo 6.5-14). In this zone, large deformation and damage were seen on both of upper structures and foundations of houses in the housing area. In other places with embankment sliding, deformation and damage to upper structures of houses were observed, but it seemed that there was limited significant damage to foundations. In 2-chome, Aoyama, a retaining wall for the housing area with a height of over 5 m was damaged.

Photo 6.5-13 Damage to retaining wall and house due to sliding and ground deformation
