PROCEEDINGS
OF
SYMPOSIUM ON
“Future of post-disaster assessment for
buildings”

Feb. 5, 2020

Building Research Institute (BRI)
National Graduate Institute for Policy Studies (GRIPS)

Symposium on
“Future of post-disaster assessment for buildings”

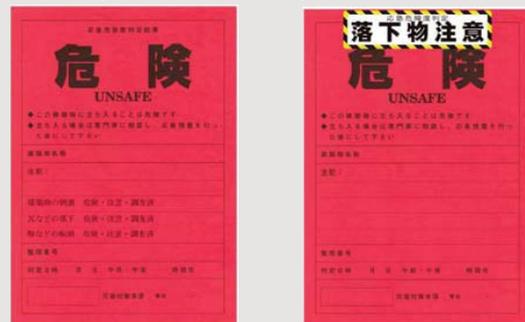
➢「危険度の原因の区別明確化(建物か落下物か等)」への対応：判定ステッカーの見直し

注記欄の見直し

シールの貼付

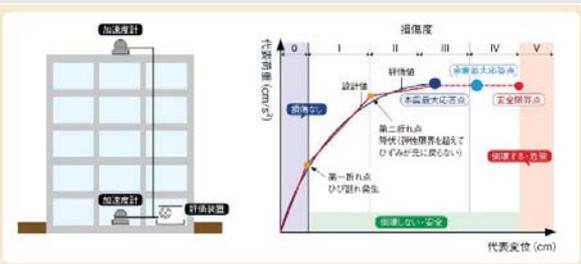
◆参考：概念図

建物の数カ所に安価な**加速度計**を設置し、**評価装置**（安価なコンピュータ）とケーブルでつなぐ。地震を感じると、評価装置が**自動で加速度から建物にかかる力（荷重）と建物の変形（変位）の大きさを求め**、その値を縦軸と横軸に取った性能曲線を描く。**最大応答点の位置から建物の損傷度がわかる**。さらに本震最大応答点から**余震での最大応答点を推定**し、それが安全限界より手前であれば建物は余震に対して安全、越えていれば危険と判定する。

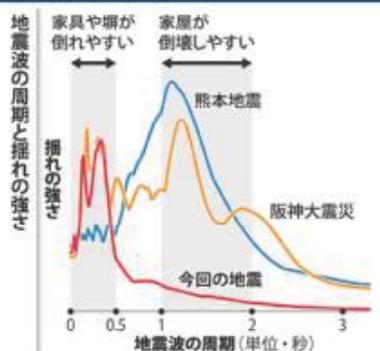
（横有記・筑波大学教授が、観測データから今回の地震波を分析した結果を、毎日新聞が掲載）

今回の地震は、極短周期の揺れが強かったため、建物構造まで被害を及ぼす全壊や半壊の被害は少なく、住家被害の多くは一部損壊。また、ブロック塀の倒壊や割れ、傾き等の被害が生じた。

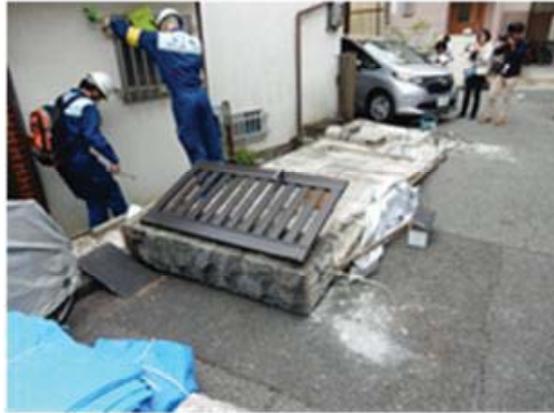
判定現場の写真(今回の地震で多く生じたブロック塀の転倒)

○この写真は、今回の地震で多く生じたブロック塀の転倒写真です。

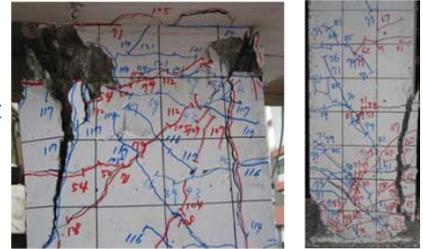
損傷度 III

中度～重度の損傷
 限界に近づいてはいるが強度は8割まで低下していない。

外側コンクリート剥落

3 mm < ひび割れ幅 ≤ 3 mm
 1 mm < せん断ひび割れ幅

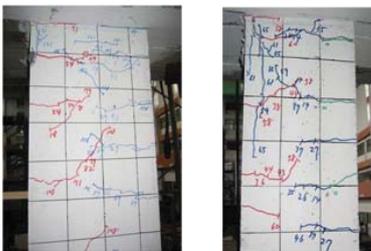
損傷度 II

軽度～中度の損傷
 降伏が見られるが最大限には達していない

0.3 mm < ひび割れ幅 ≤ 3 mm
 せん断ひび割れ幅 < 1 mm

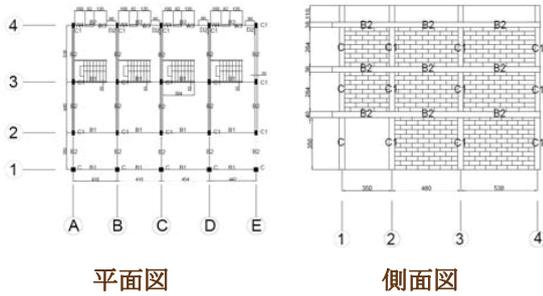
建物例 1

3階建RC造建築物

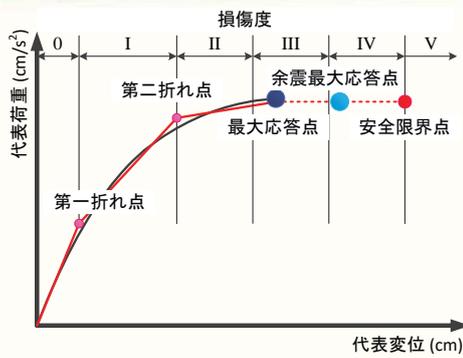
本震と余震の損傷度

損傷度

代表荷重 (cm/s²)

安全限界点

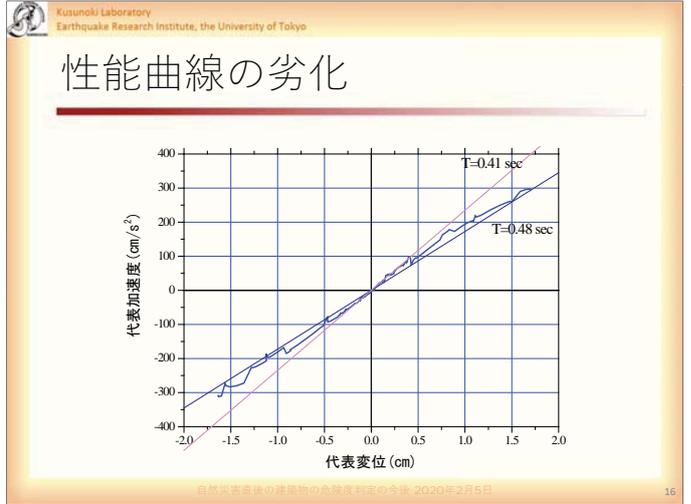
例1 横浜国立大学

- 連層壁の脚部に軽微な曲げひび割れ
- 実被害状況とよく対応している
- システムは有効に稼働
- 結果は、建築学棟の教員に伝達された

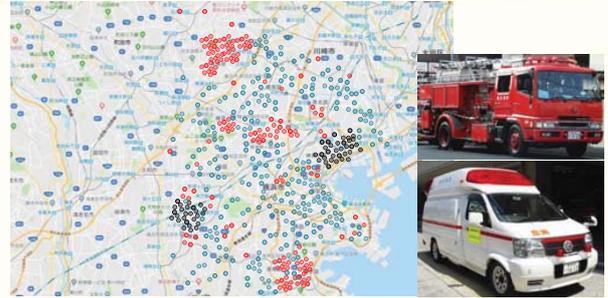
地域の被災状況把握

- 地域の被災状況を面的にリアルタイムで把握

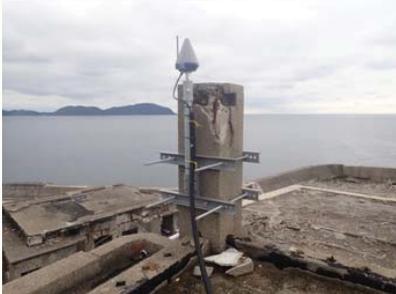
その他の技術：GPS観測

G-1～8（30号棟設置機器）：屋上の柱に治具固定＋
電源は3号棟のソーラーパネルから送電

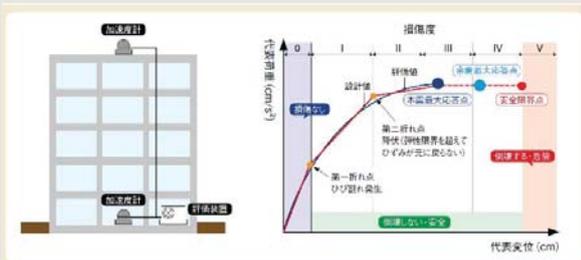
◆ Reference: Conceptual diagram
Inexpensive accelerometers are installed in several places in the building, and connected to evaluation devices (inexpensive computers) with cables. When an earthquake is detected, the evaluation device automatically calculates, from the acceleration, the magnitude of the force (load) applied to the building and the magnitude of the deformation (displacement) of the building, and draws a performance curve using the values on the vertical and horizontal axes. The degree of damage to the building can be determined from the position of the maximum response point. Furthermore, the maximum response point in the aftershock is estimated from the maximum response point of the main shock, and if it is before the safety limit, the building is determined to be safe for the aftershock, and if it exceeds, it is determined to be dangerous.

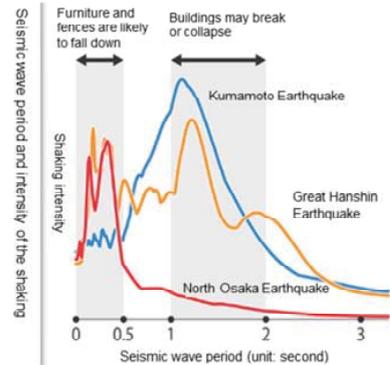
(Excerpt from Mainichi Shimbun: The graph shows the result of seismic wave analysis performed by Professor Yuki Sakai of Tsukuba University based on observation data)

Very short-period waves were strong among the wave components in the North Osaka Earthquake. As a result, few housings suffered damage to the building's construction as in cases of complete or half collapse, and most of the affected housings were only partially damaged. Collapse, crack and tilting of concrete-block fences were also observed.

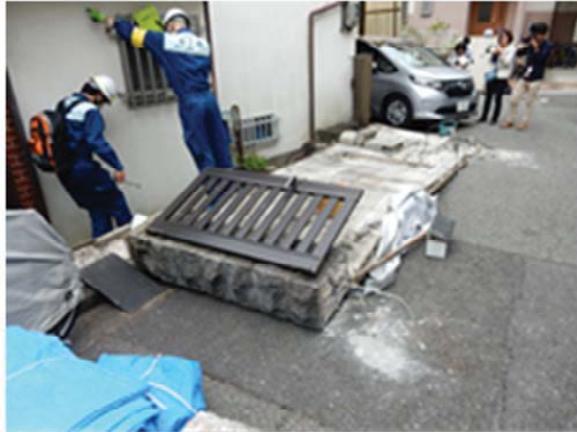
On-site inspection
(One of the many sites where a concrete-block fence fell down)

○ This photo shows a collapsed concrete-block fence, a typical damage caused by the North Osaka Earthquake.

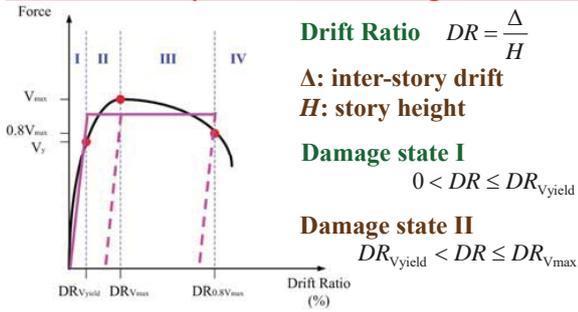
Inter-Story Drift and Damage State

Drift Ratio $DR = \frac{\Delta}{H}$
 Δ : inter-story drift
 H : story height

Damage state I
 $0 < DR \leq DR_{V_{yield}}$

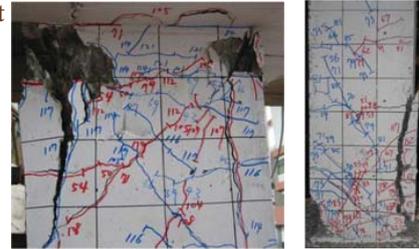
Cover concrete spalling

Moderate to severe damage
 Maximum strength developed but not degraded to 0.8 times yet

3 mm < Flexural crack width ≤ 3 mm
1 mm < Flexural shear crack width

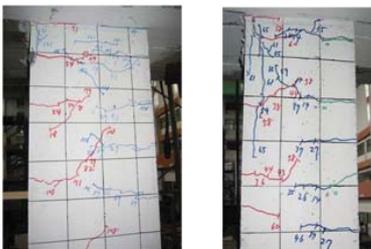
Damage State II

Light to moderate damage
 Yielding strength developed but not maximum yet

0.3 mm < Flexural crack width ≤ 3 mm
Flexural shear crack width < 1 mm

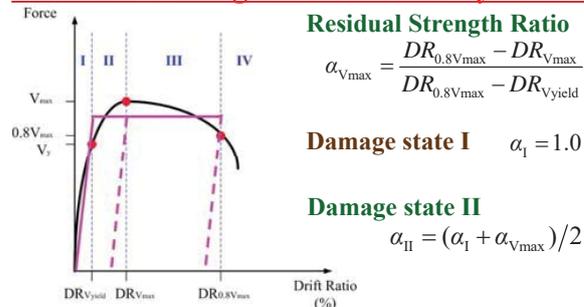
Residual Strength and Inter-Story Drift

Residual Strength Ratio
 $\alpha_{V_{max}} = \frac{DR_{0.8V_{max}} - DR_{V_{max}}}{DR_{0.8V_{max}} - DR_{V_{yield}}}$

Damage state I $\alpha_I = 1.0$

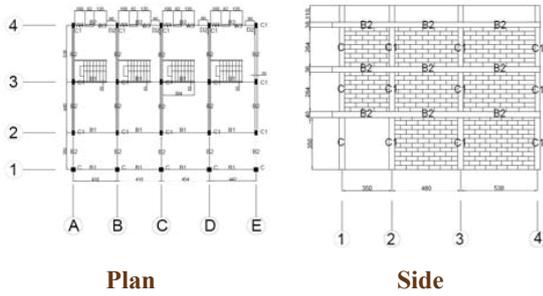
Example Building 1

3-story RC building

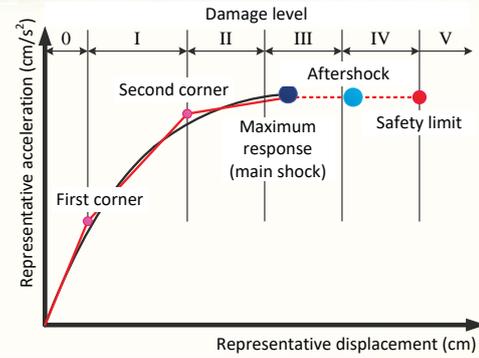
Damage evaluation and prediction

Damage level

Representative acceleration (cm/s^2)

Safety limit

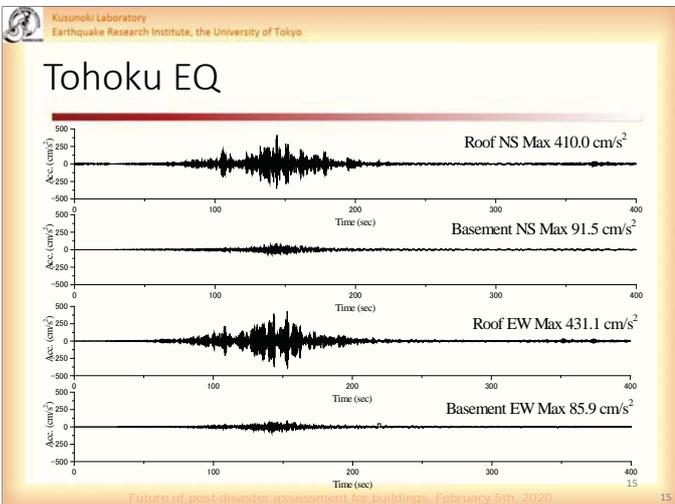
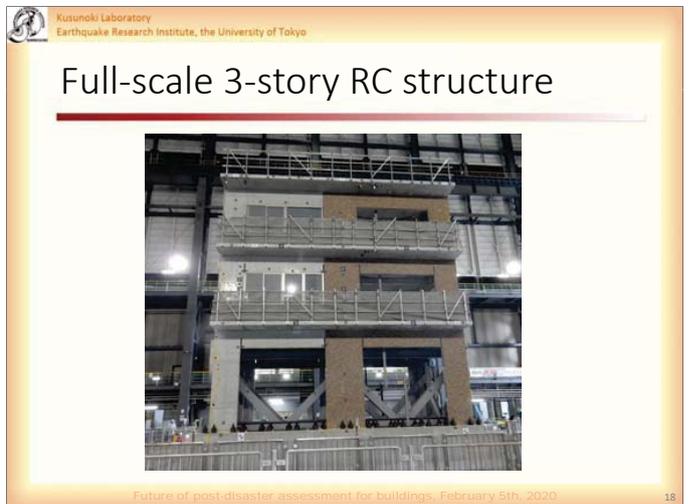
1st 150% input

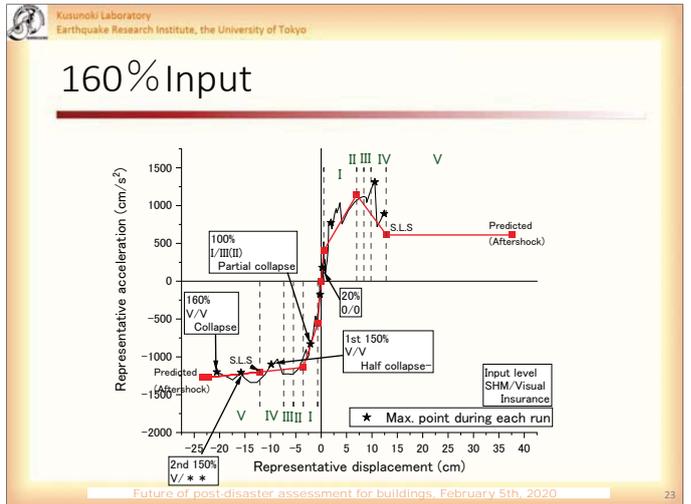
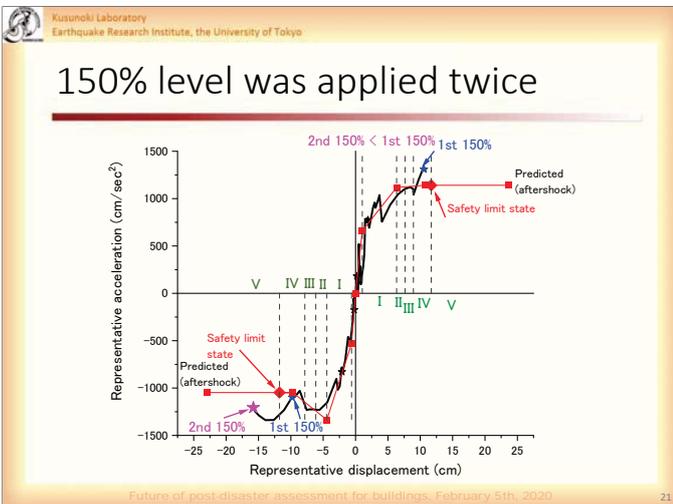
2nd 150% input

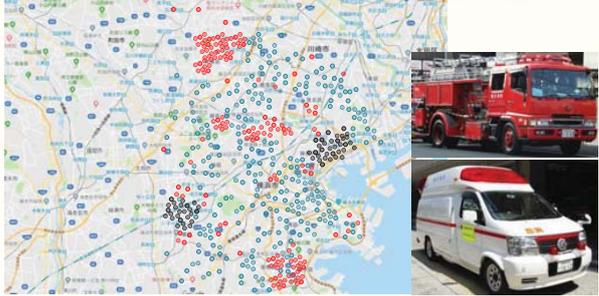
Damage evaluation of cities

- Damage condition of cities can be evaluated soon after an EQ

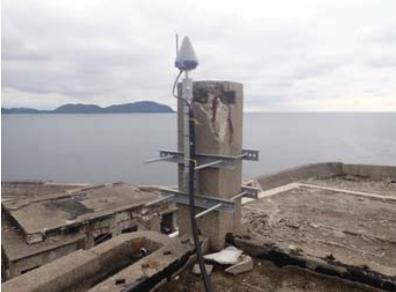
Other technique : GPS observation

Solar power supply is used on GUN-KAN Jima island,
BRI: Tomohisa Mukai
