6. Damage to Buildings by Earthquake Motions

6.1 Policy on Earthquake Damage Investigation for Buildings

6.2 Damage to Wood Houses

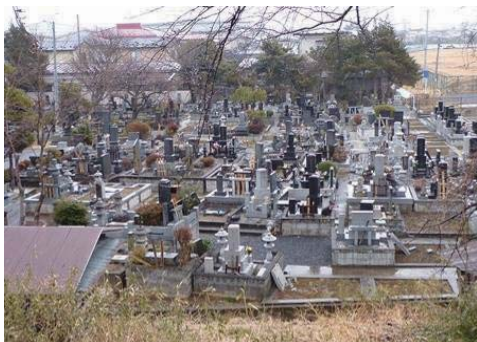
Photo 6.2-7 Overturning of tombstones

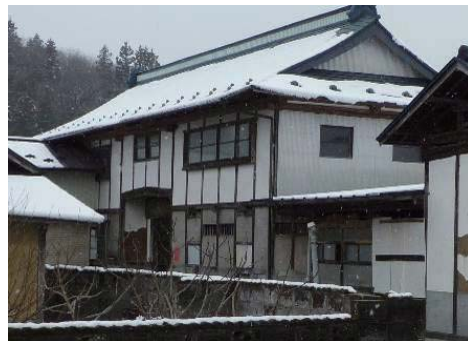
In Kurikomasakurada district, collapse of work hut, drop of the mud plasters of Nagaya-mon gates (Photo 6.2-8), damage of plastered storehouses were observed, but any heavy damage in house was not observed.

Photo 6.2-8 Drop of mud plasters of Nagaya-mon gate (Kurikomasakurada)

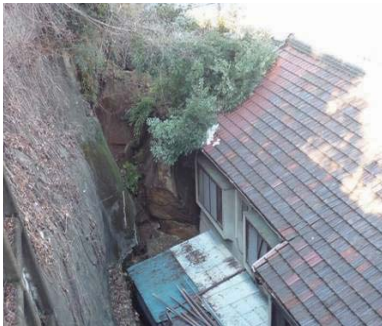
Photo 6.2-43 Hillback of the hotel

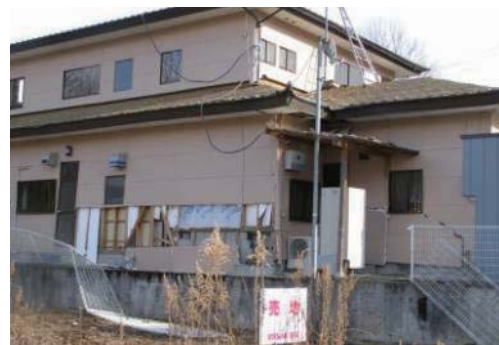
In Nishi-Ohkubo area, several wood houses whose exterior mortar wall in the 1st floor was almost failed were found (Photo 6.2-62). And, the wood house with large story drift (Photo 6.2-63) and the other one damaged due to deformation of the residential land (Photo 6.2-64) were found.

Photo 6.2-64 Damaged house due to deformation of residential land

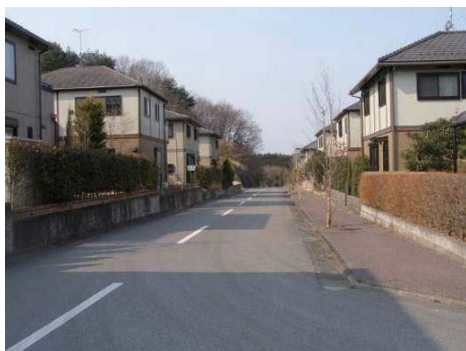
Photo 6.2-65 No damaged houses at Lobin-city area

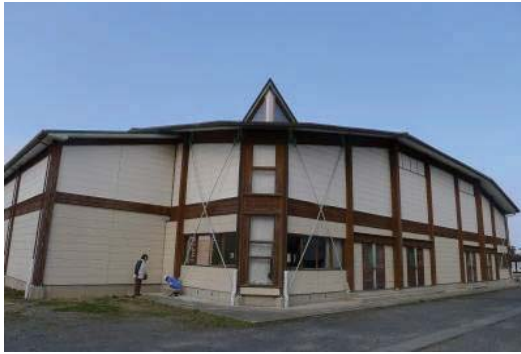
At the wood gymnasium (Photo 6.2-76, Photo 6.2-77) with curved glue laminated timber built in 1985-1989 in Urizura, buckling and tensile failure of the steel braces, the breakages of the foundation concrete at the brace joint were observed (Photo 6.2-78). At the wood school building (Photo 6.2-79), the slip of wood braces (Photo 6.2-80), the deformation of steel roof plate, wood flooring and interior material due to the contact with the stairway made by reinforced concrete were observed.

Photo 6.2-76 Wood gymnasium

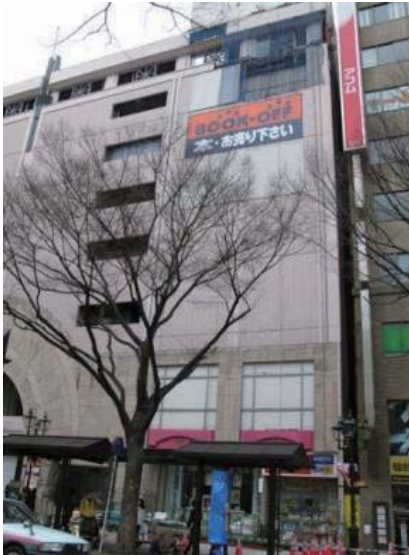
Photo 6.3-47 Damaged building with AAC panels (Aoba ward, Sendai city)

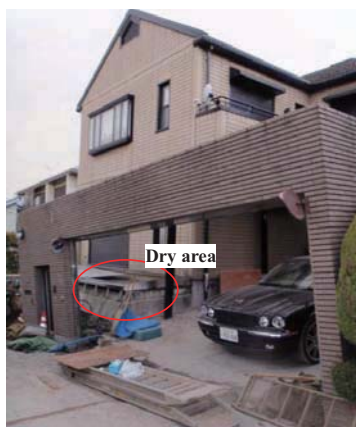
Photo 6.5-8 Tilted house

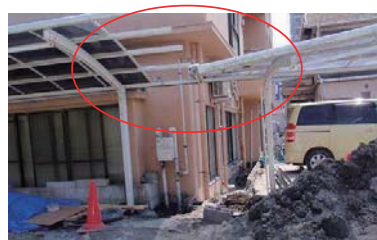
Photo 6.5-9 Moved carport

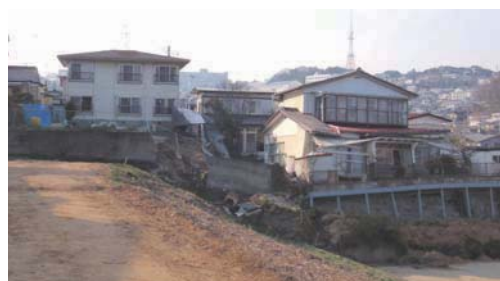
Photo 6.5-14 Group of houses damaged due to sliding and ground deformation

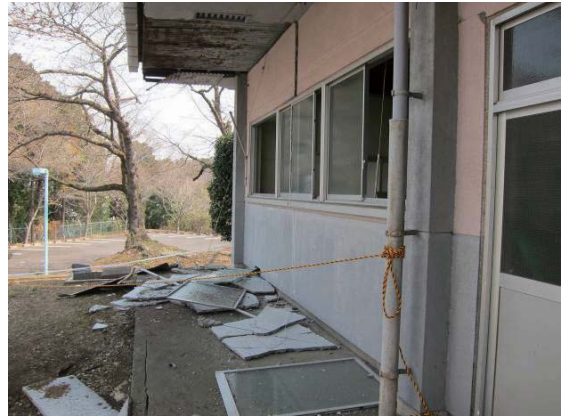
Photo 6.6-4 Falling of cement mortar and metal lath from eaves soffit
